Nunnallee Inspections

Commercial Inspection

Sample Inspection Report

PROPERTY INSPECTION REPORT

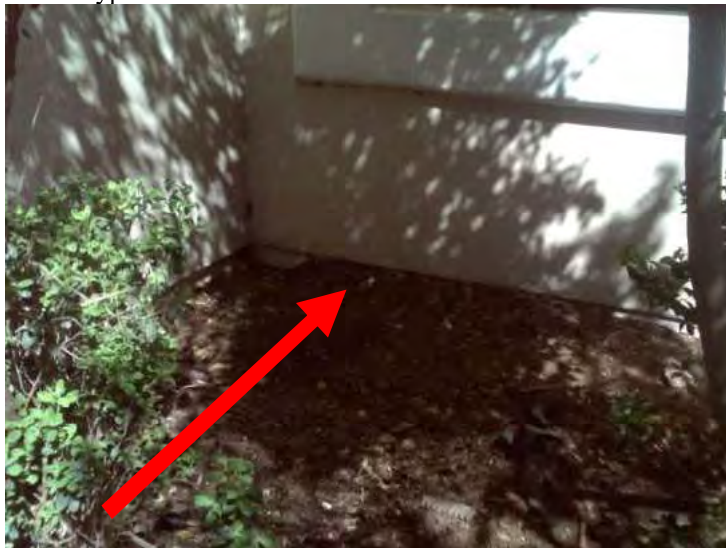
The soil line in one location at the front of the building is too high. Under current building standards there should be at least 4-inches of foundation visible below masonry veneer and 6-inches of foundation visible below wood type veneer.

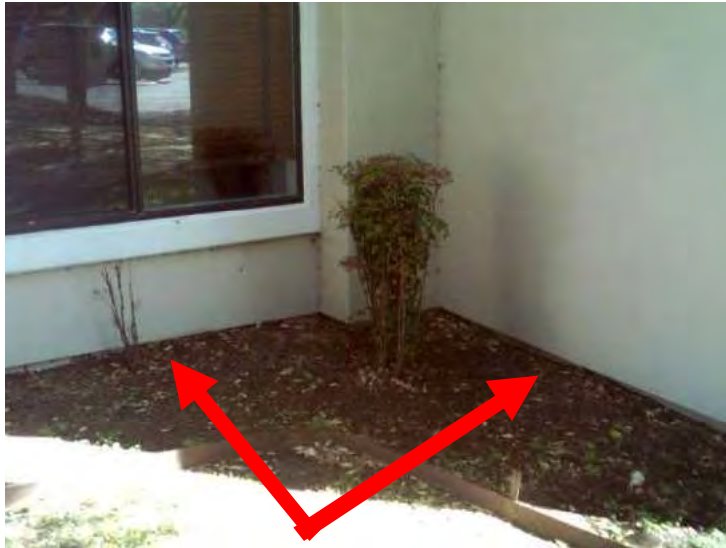
The soil line at the south west corner is marginally high. Under current building standards there should be at least 4-inches of foundation visible below masonry veneer and 6-inches of foundation visible below wood type veneer.

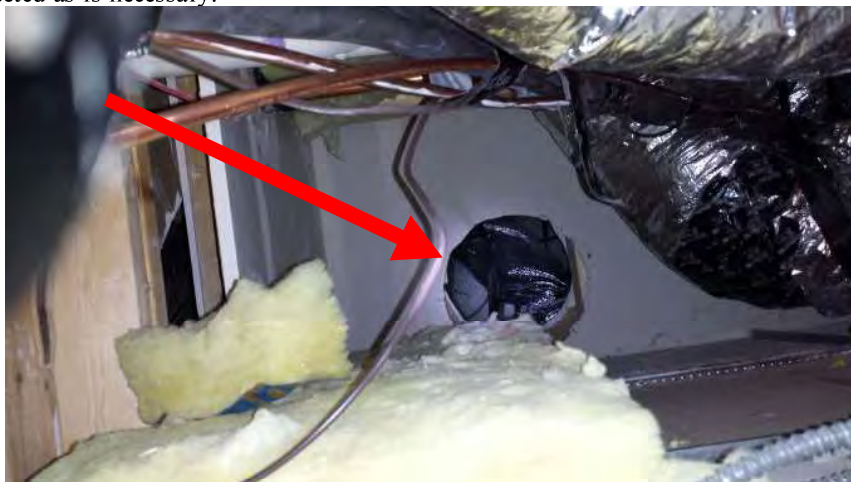
The firewall in more than one location at the rear corridor was observed to be damaged and should be corrected as is necessary.

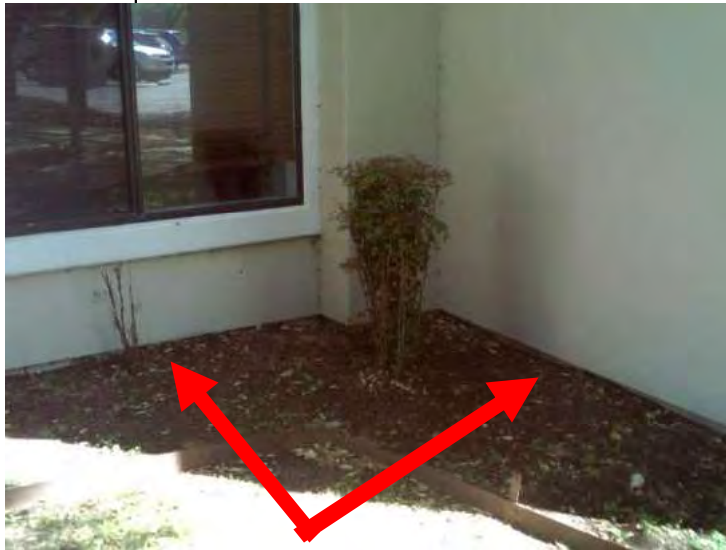
The exterior stucco type veneer/cladding has inadequate clearance from the finished grade (ground). Most manufacturers require a minimum of 4- to 6-inches of clearance from the finished grade (ground).

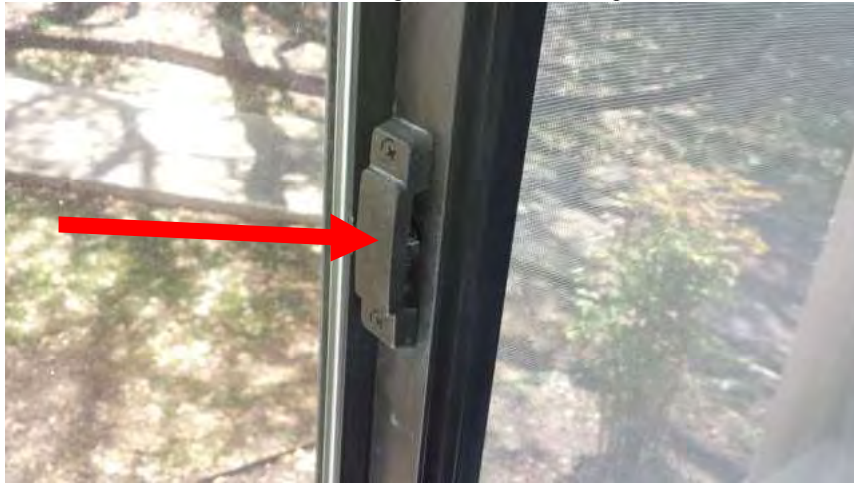
Window locks in the NW office are damaged and should be repaired.

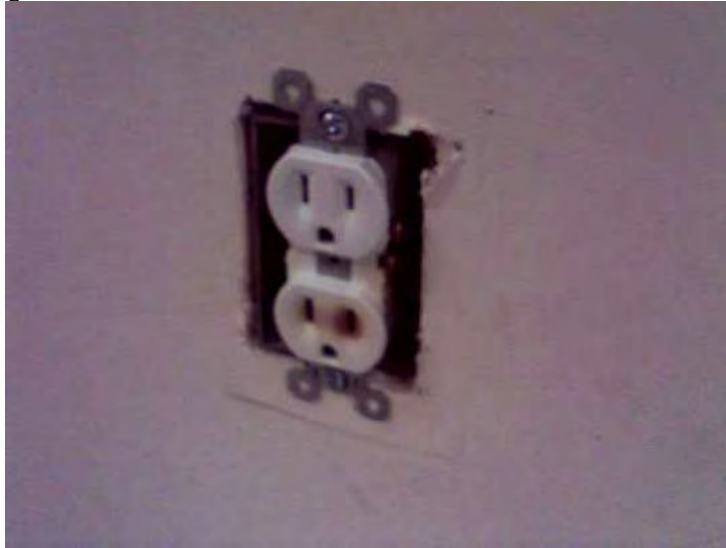
Arcing at one of the outlets in the mechanical room was observed.

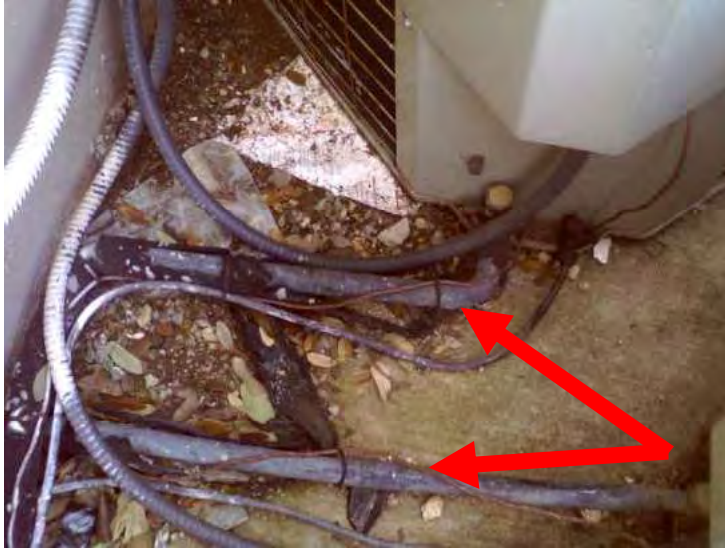
Damaged, deteriorated and/or missing insulation on the refrigerant lines should be repaired or replaced at the outside condenser.

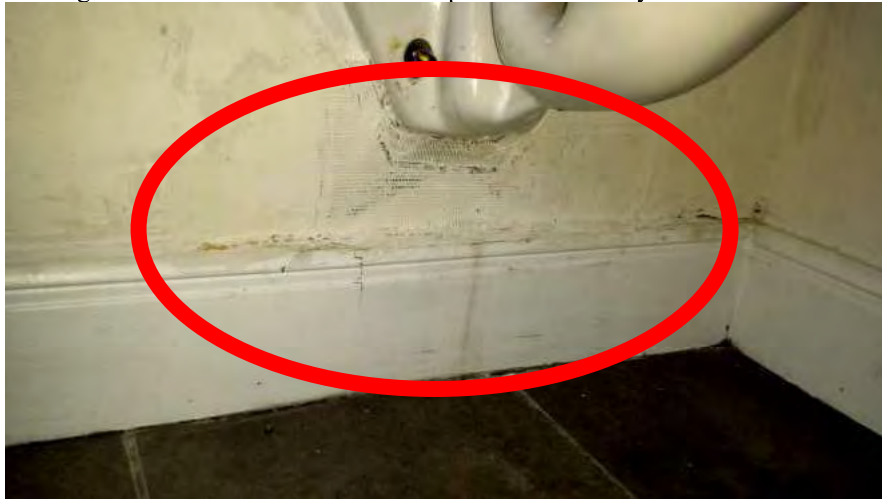
Water damage below the urinal was noted. Repair as is necessary.

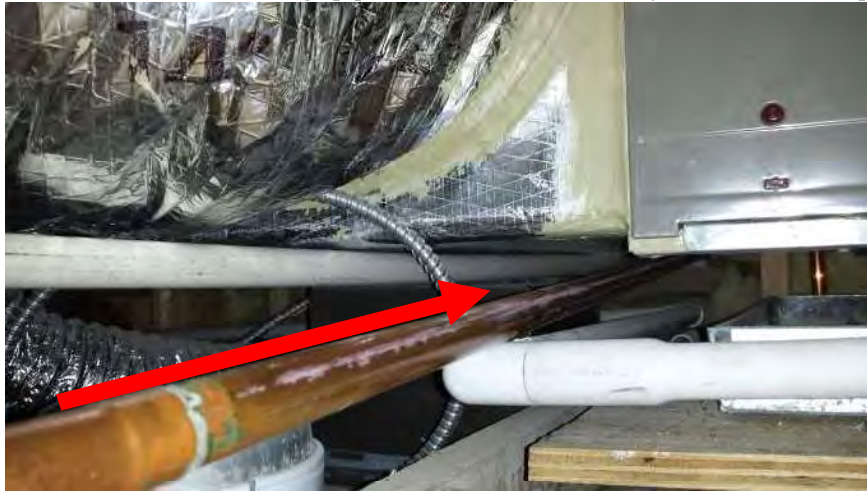
The temperature and pressure relief (TPR) valve discharge pipe is running in an upwards direction in one or more locations. The TPR discharge pipe should run gravitationally downwards at all points.

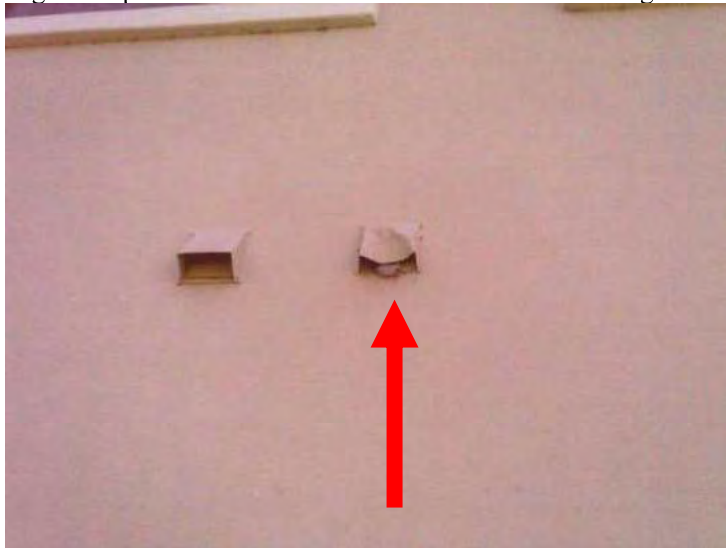
A damaged damper cover was observed at the rear of the building.

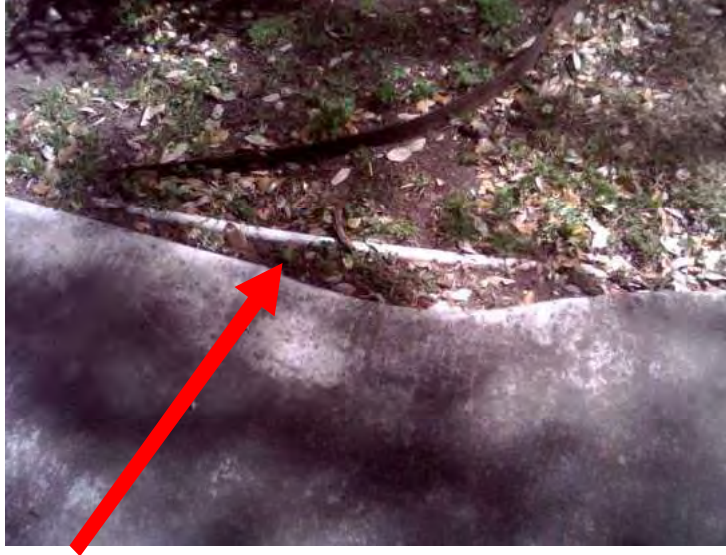
NOTE: It is recommended that exposed water lines for the sprinkler system be buried to lessen the potential of damage.

It is recommended that exposed water lines for the sprinkler system be buried to lessen the potential of damage.
