Nunnallee Inspections

Commercial Inspection 2

Sample Inspection Report

PROPERTY INSPECTION REPORT

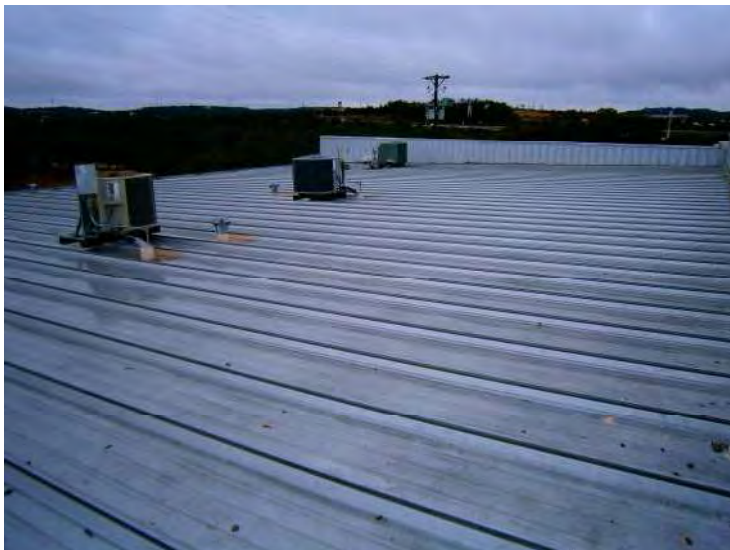
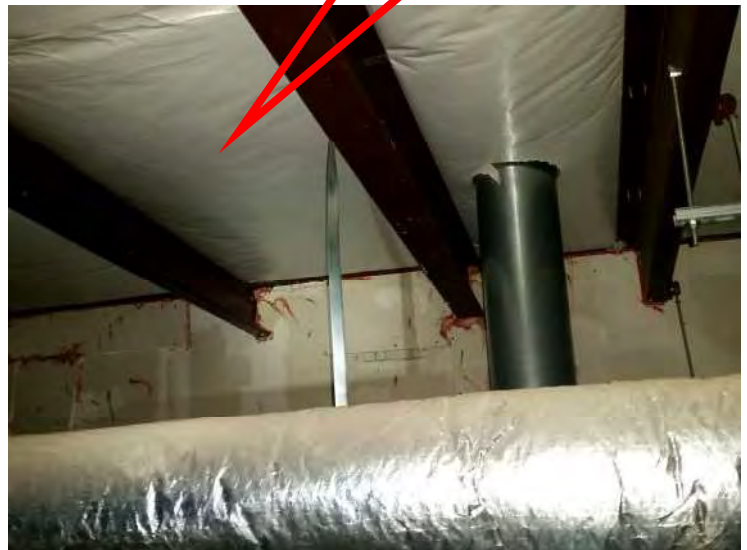
Standing seam metal roofing over insulation

Vapor barrier below insulation.

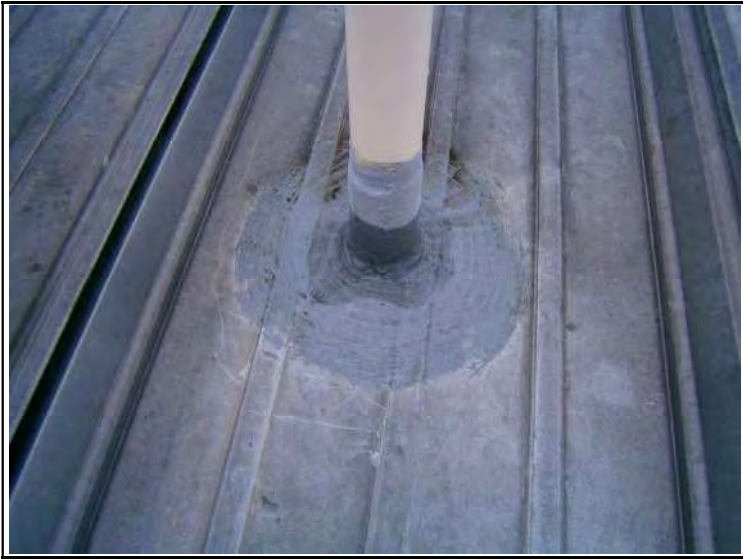
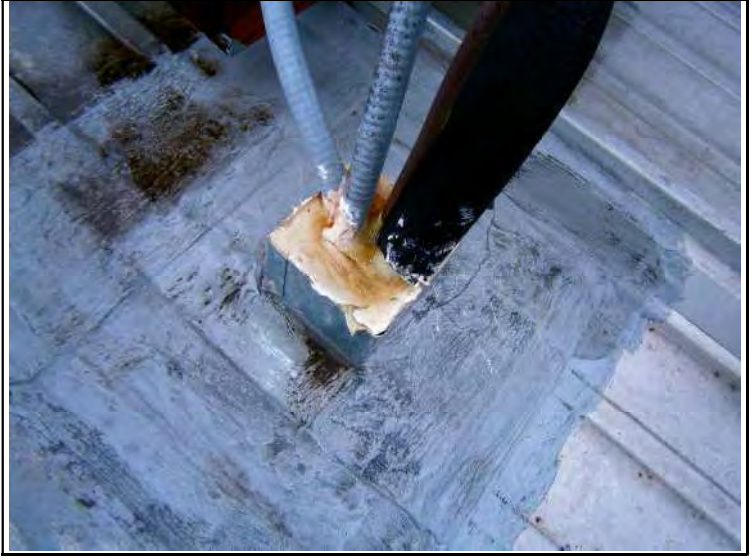
No deficiencies observed at the time of inspection. All penetrations appeared to be properly sealed and performing as intended.

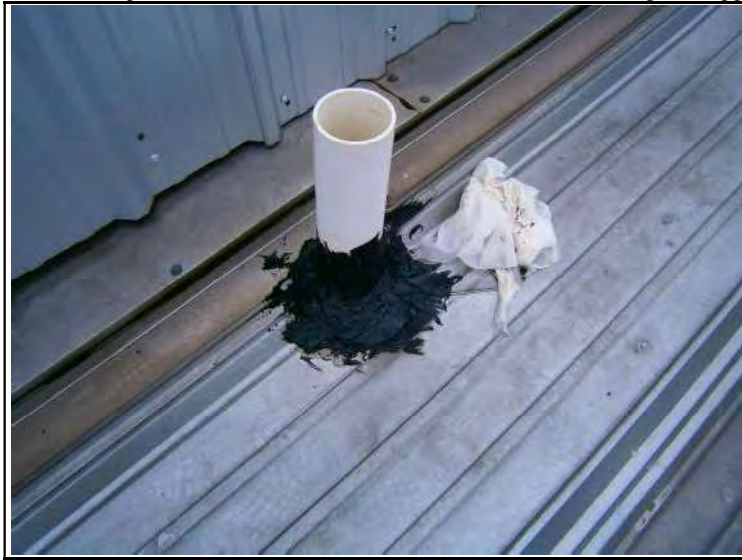
One area of repair was observed at the rear of the West building and appears to be performing as intended.

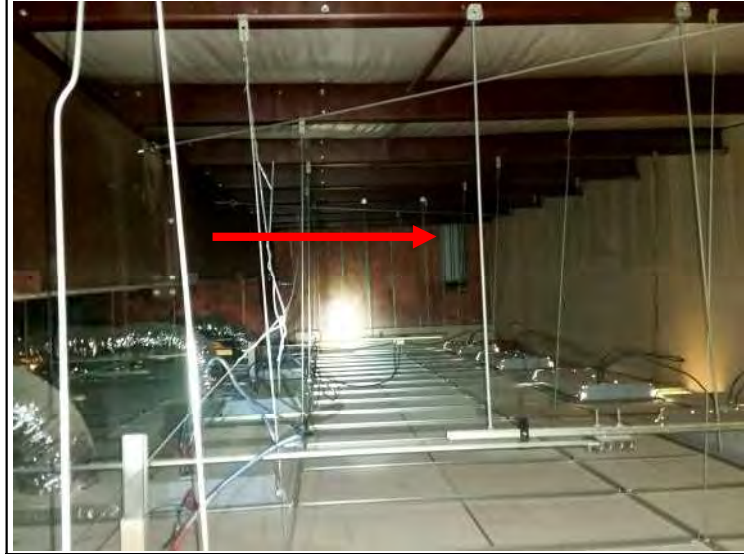
The sidewall insulation was observed to be missing in one area above the ceiling in the vacant space. The lack of this insulation will cause greater heat gain and should be replaced.

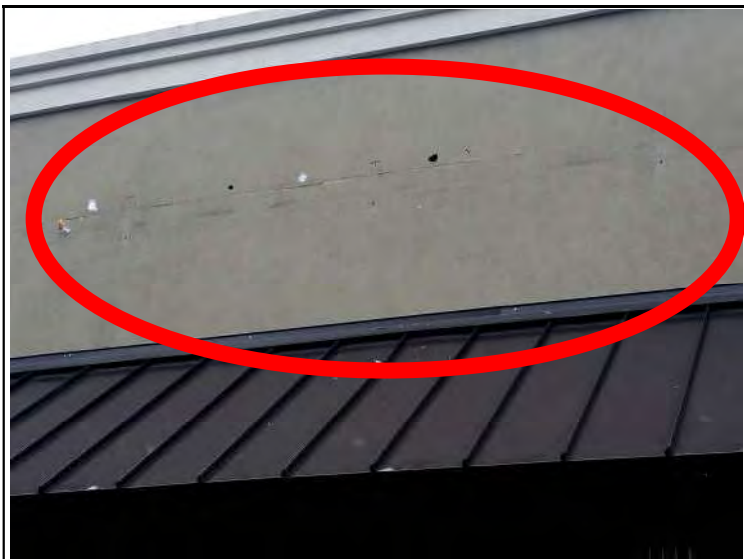
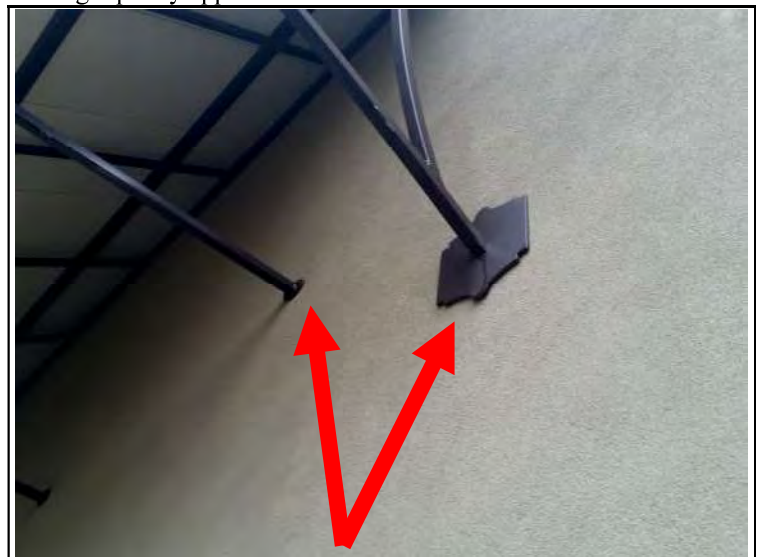
All stucco penetrations should be sealed with a high quality approved sealant.

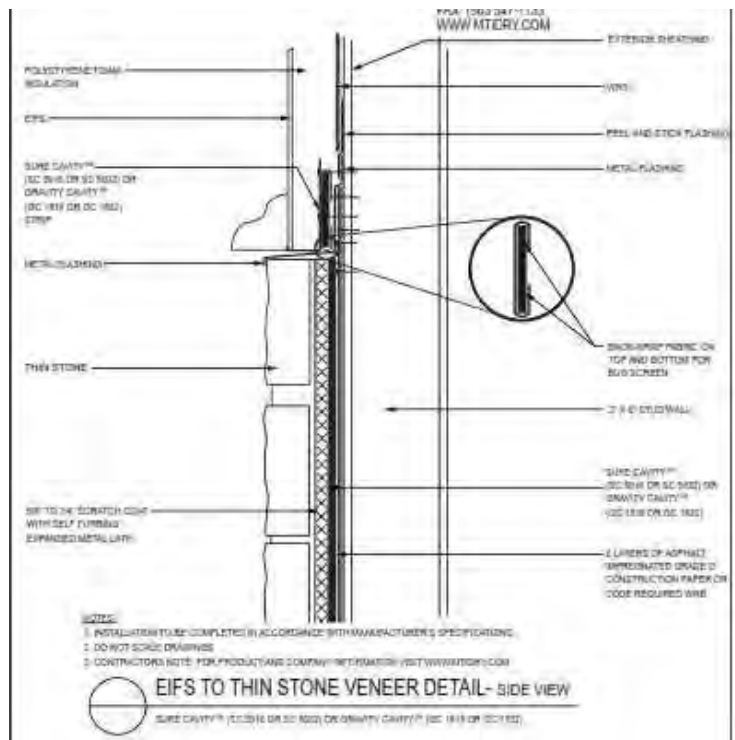
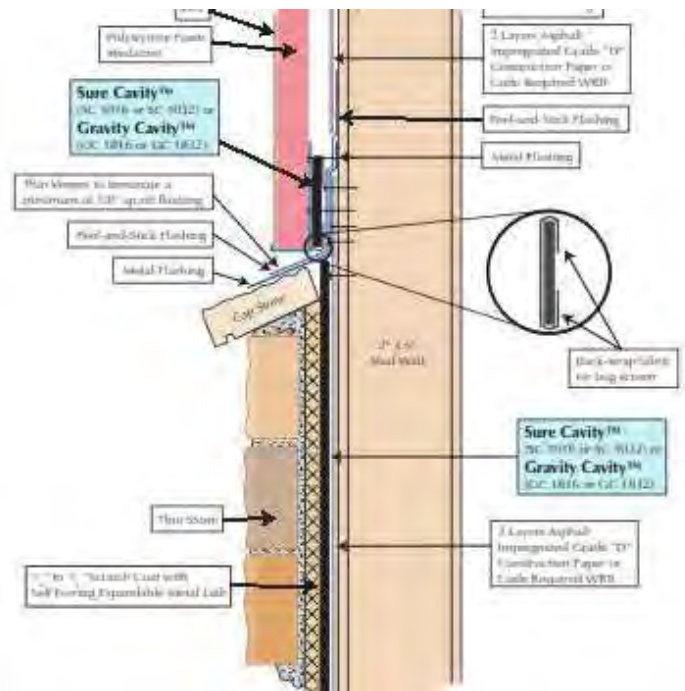
S. Wall of East building. This is the Dr. office where water damage was sustained

- All stucco penetrations should be sealed with a high quality approved sealant.
- The stucco cladding/stone wainscoting intersections appears to be installed in a manner that is conducive to water infiltration. This condition appears to be the source of the previous water breach at the South end of the East building. I am including optional installation details for this type of transition. It is recommended to have this transition corrected in a manner which is consistent with manufactures recommendations.

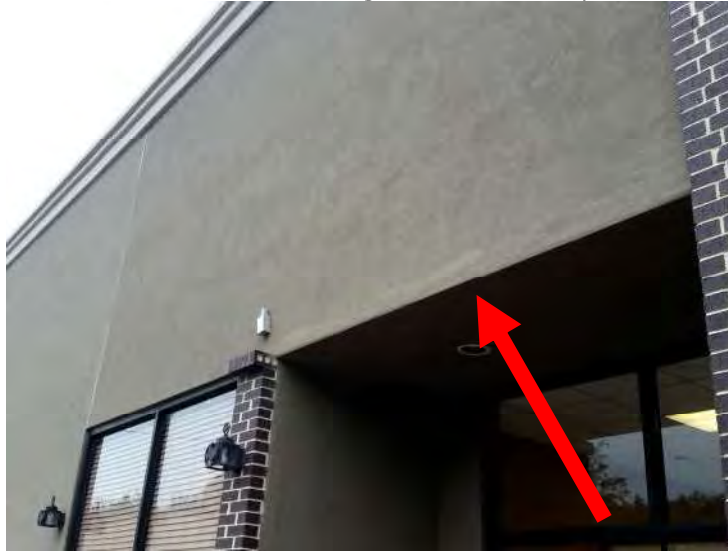
The bottom edge of the stucco is required to finish out with a continuous piece of flashing (bead casing w/weep holes) the absence of this flashing can prevent this plane from draining as intended. This is an undesirable condition and should be repaired as is necessary.

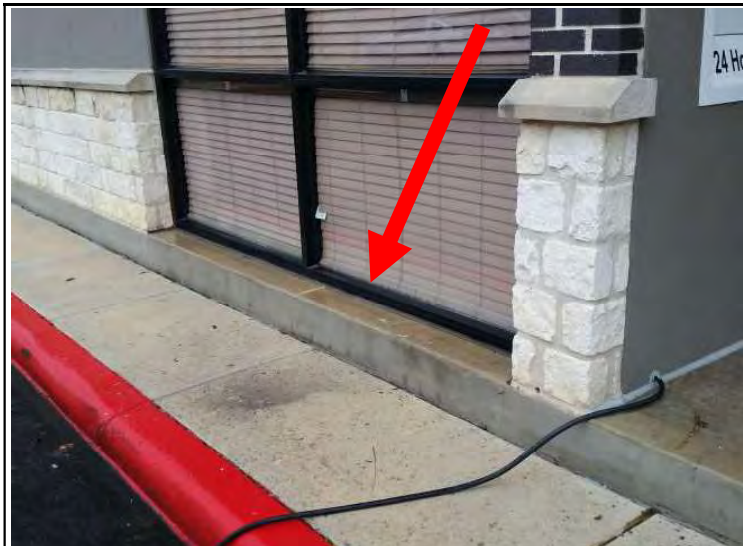
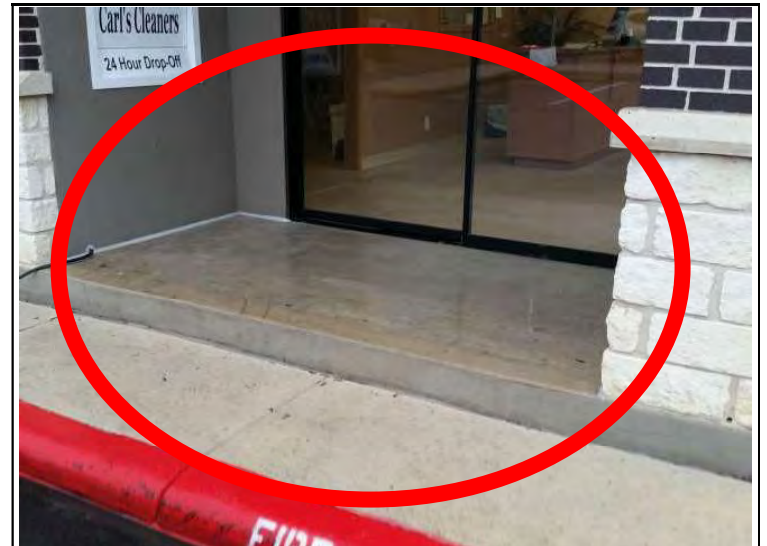
There is evidence of previous repairs at this location. "Cleaners"

The lack of a pitch at these locations can promote poor drainage and water entry into the building. This is the cleaners where a considerable amount of water entered.

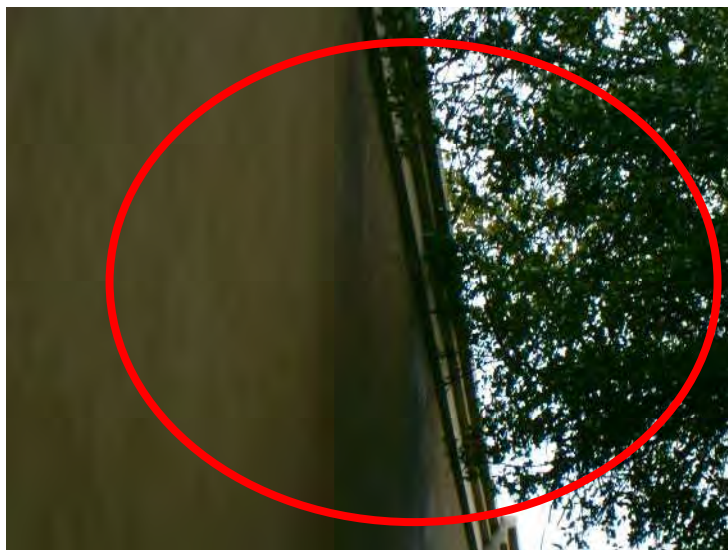
The trees at the North wall of the East building need to be cut back. EIFS is a very flexible material and can easily be damaged from tree limbs.

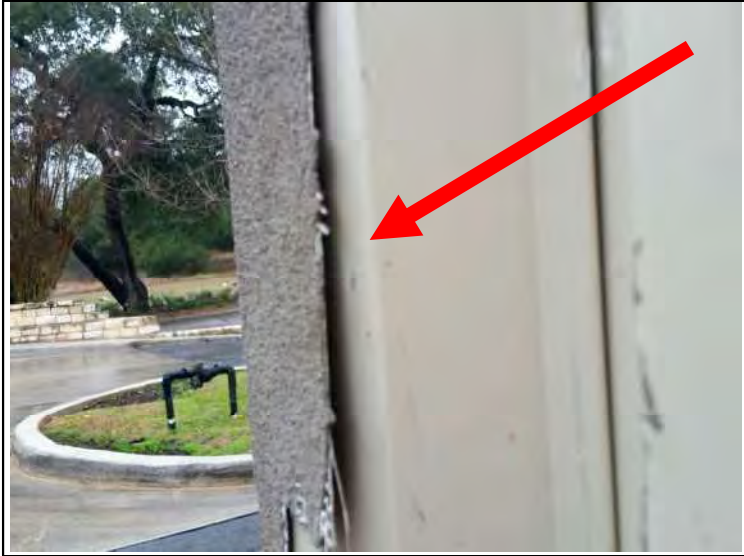
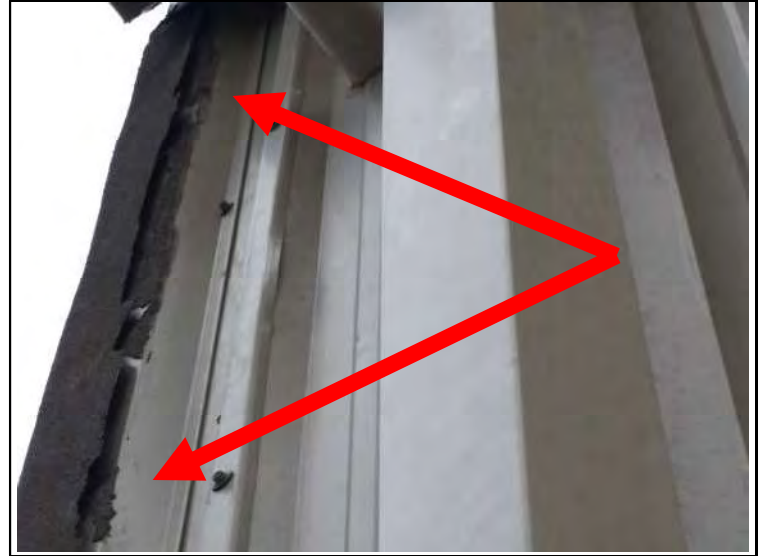
The wrap detail at the stucco/metal siding transition, rear corners, is peeling back and does not appear to be finished in a manner consistent with most manufacturers' installation guidelines. This area will need to be improved to prevent potential water penetration.

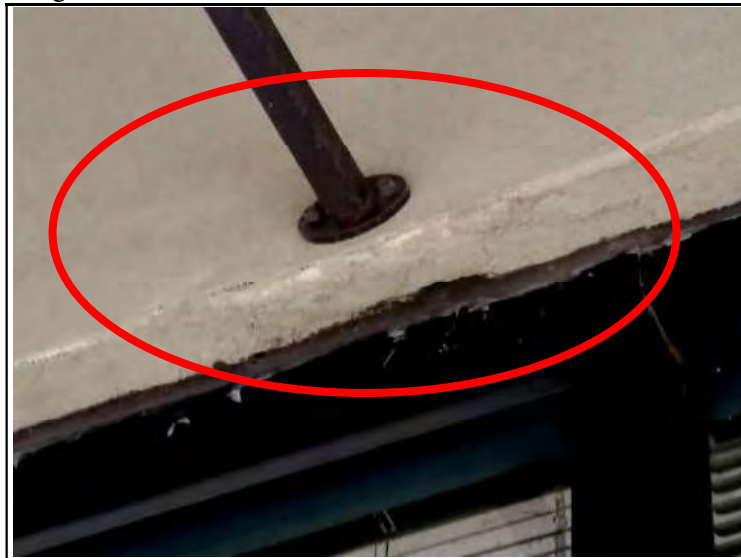
NOTE: Previous repairs to the stucco veneer (EIFS) were observed at a few locations along the front of the building.

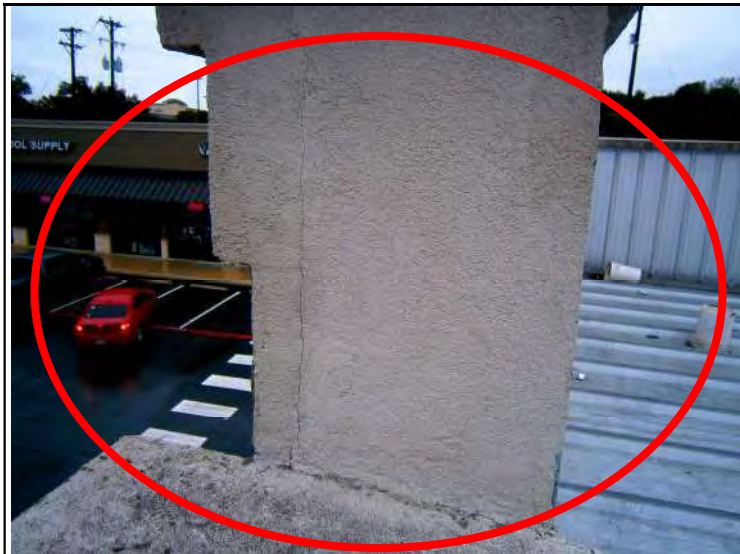
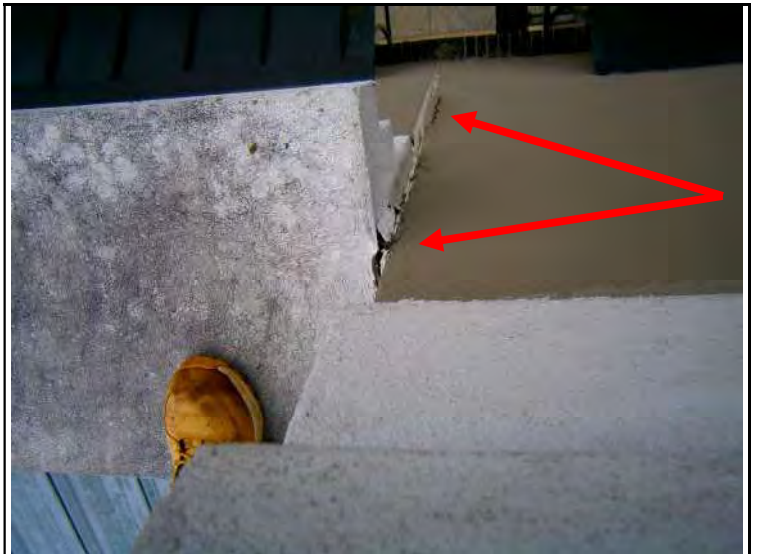
One or more locations at the parapet wall transitions need to be re-sealed.

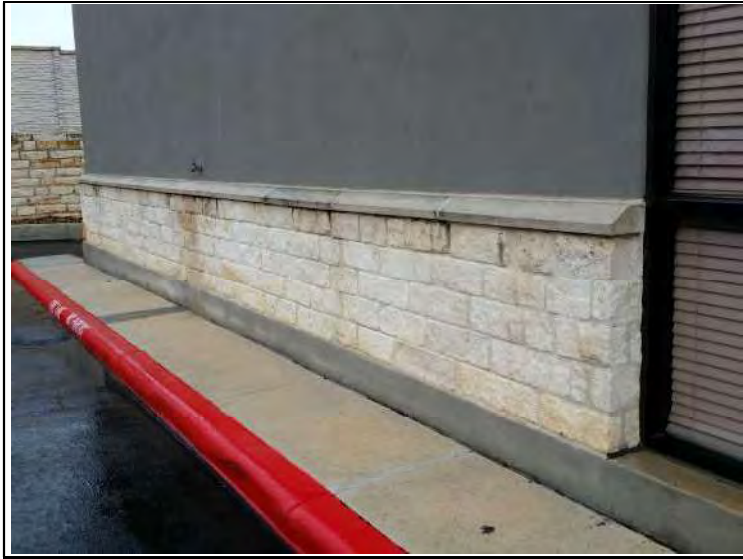
There are not enough weep-holes in the lower course of masonry wainscoting. This was observed at the East exterior wall of the cleaners. Weep-holes in the lower course of the masonry veneer, no more than 33" apart, to help drain water from the interior of the wall voids.

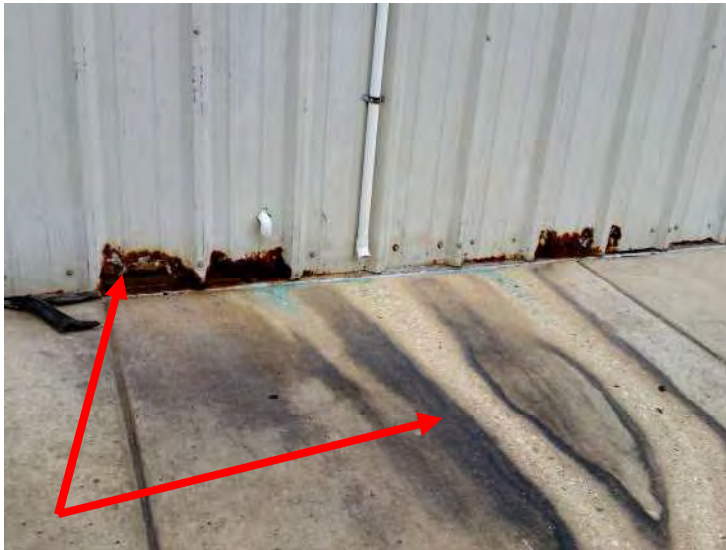
The metal siding has some deterioration and/or damage along the bottom at the rear side of the BBQ restaurant.

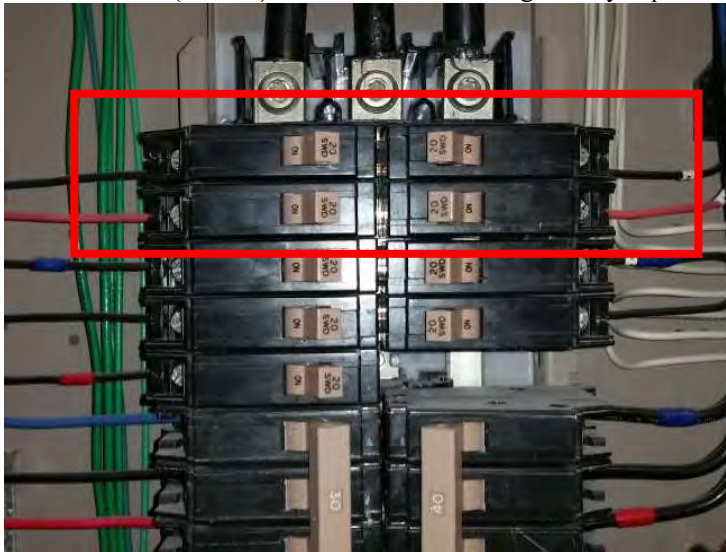
One or more of the breaker trip-ties appear to be missing. The 120V overcurrent devices (breakers) sharing a grounded conductor (Neutral) should be connected together by trip-ties.

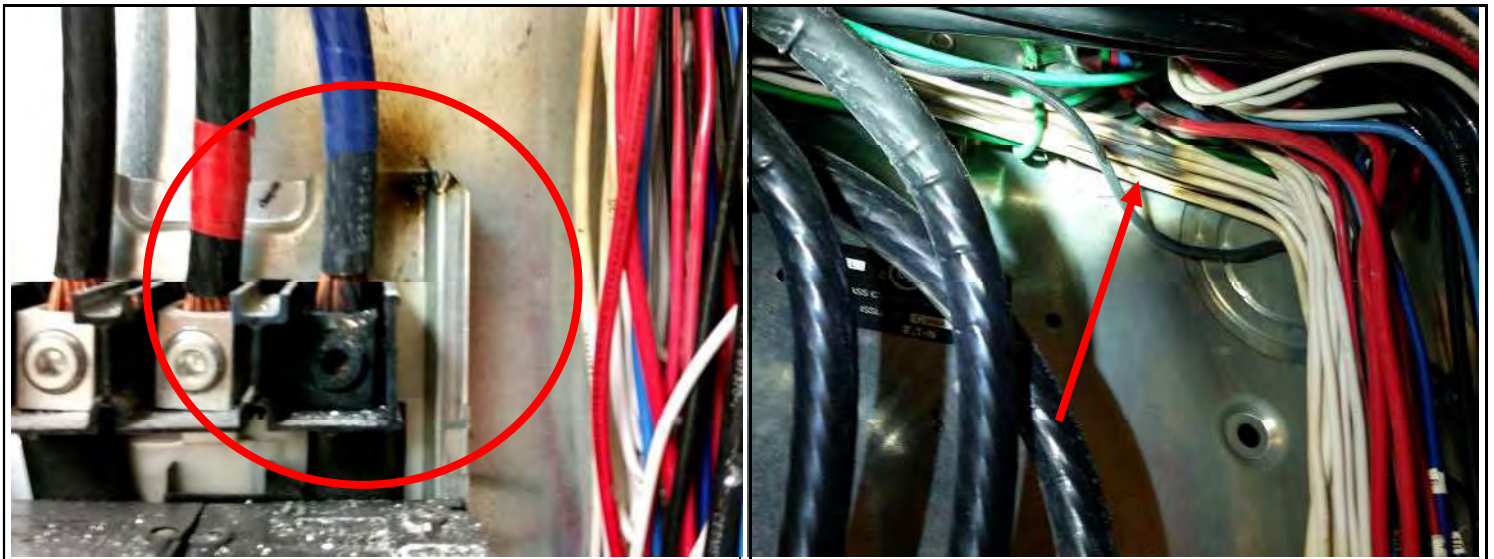
Flash damage was observed in the (Pool Co.) sub-panel. This was caused by a direct ground fault with an electrician's tool. The damaged is caused by flash of energy.

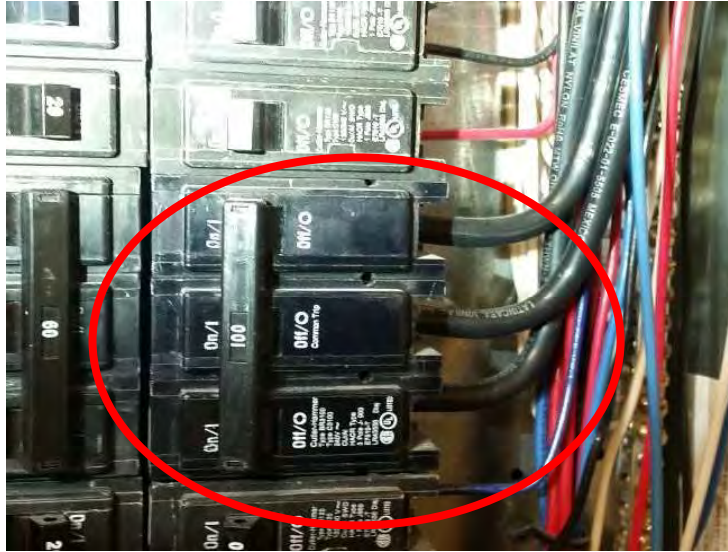
There is a 100-amp breaker wired with a 85-amp wire. The breaker in place is not listed or labeled for this type of installation. This condition should be further evaluated and corrected as necessary. (Sub-panel Pool company)

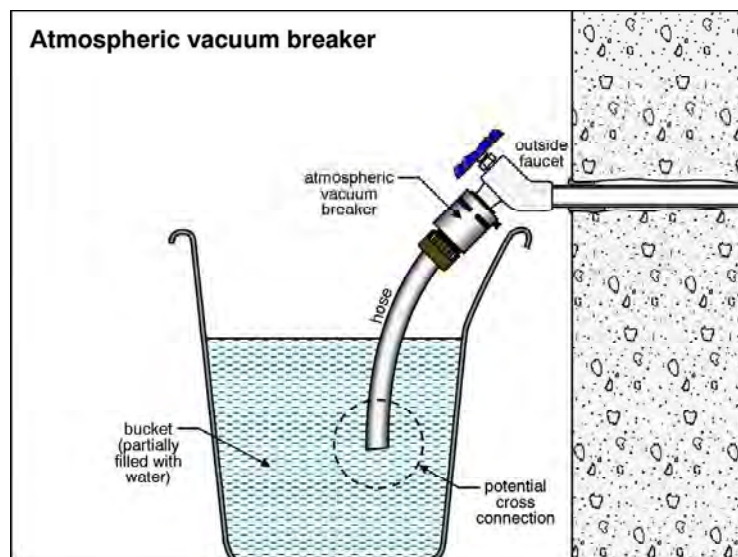
One or more of the exterior water hose bibbs (faucet) do not have a back-flow or anti-siphon device (Vacuum Breakers) in place. **Note:** *This is not uncommon to observe with a home of this age.*

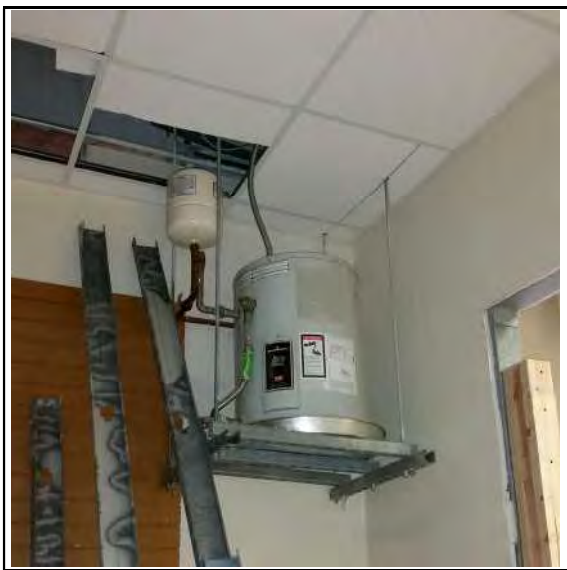
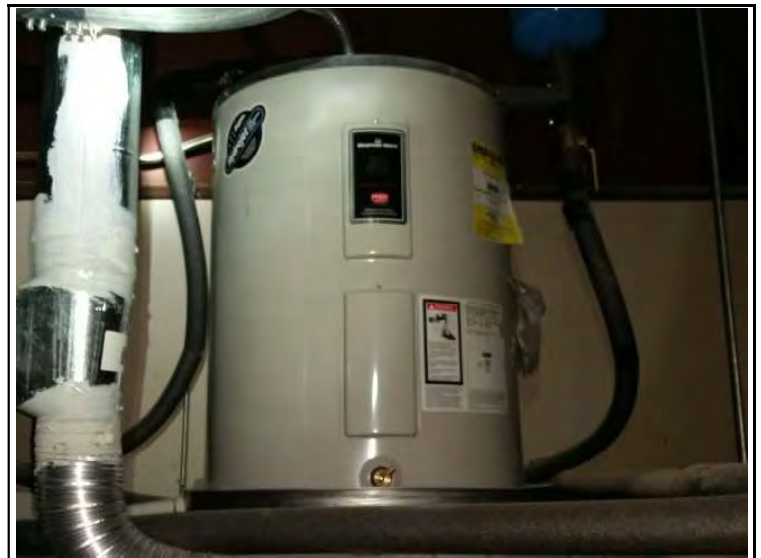
The water heaters all appeared to be installed in a manner consistent with industry standards.

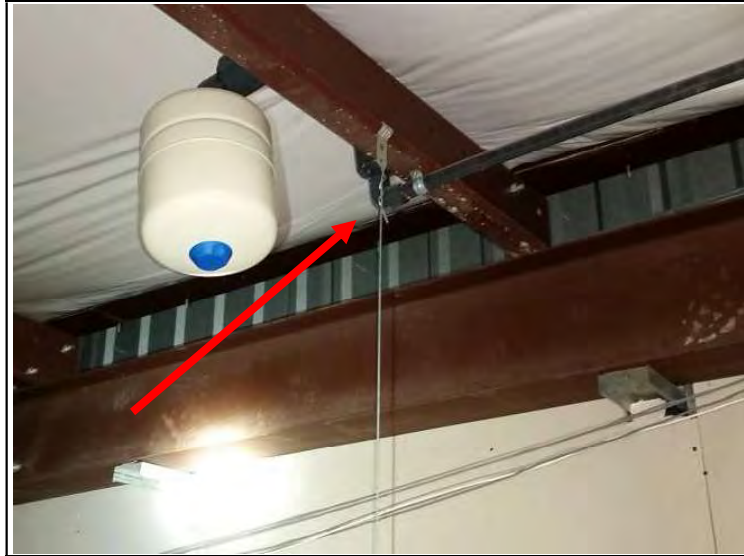
A water leak (drip) was observed above the suspended ceiling (Pool Company). The source of the leak is the supply line to the expansion tank. Minor improvement needed.

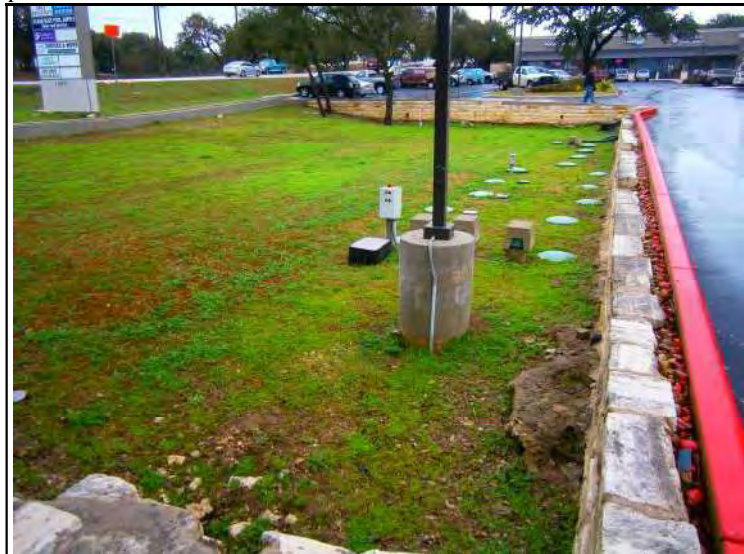
Aerobic Type Septic System: Due to the size of this system(s), I was not able to provide a thorough inspection.
