# *Nunnallee Inspections*

*Condo Inspection*

*Sample Inspection Report*

# PROPERTY INSPECTION REPORT

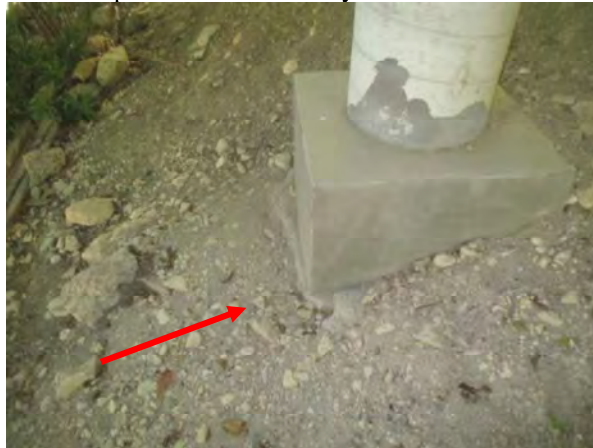
The foundation for the support at the rear of the structure is showing evidence of erosion. This should be monitor and repaired when necessary.

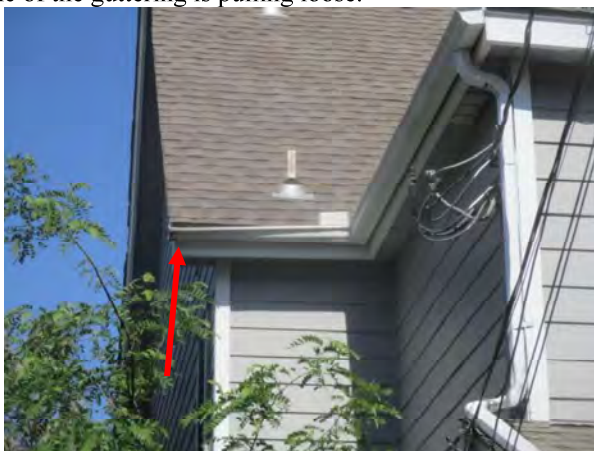
Some of the guttering is pulling loose.

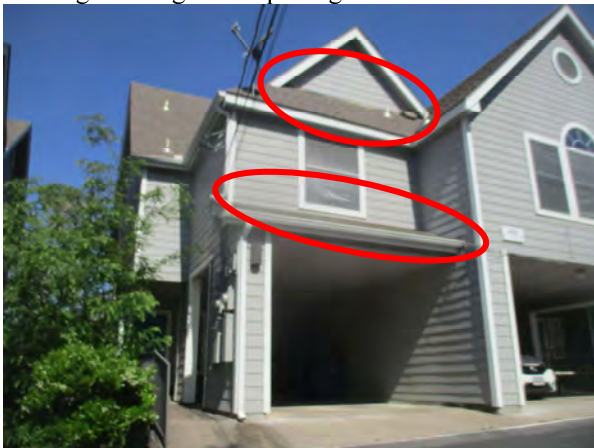
The flashing is rusting. This can be repaired by painting with a rust inhibitor paint to prevent further corrosion.

The flashing is lifting and/or pulling loose and should be re-secured.

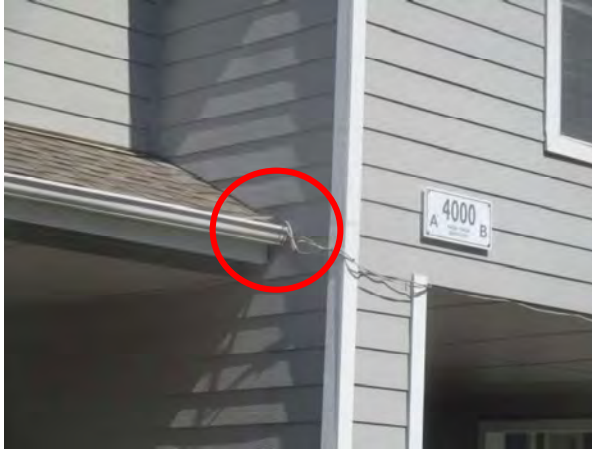
There was no kickout flashing details observed at the lower bottom edge of the roof line interface and the sidewall that continues past the edge of the roof. The lack of this kickout flashing can allow water to penetrate at these points.

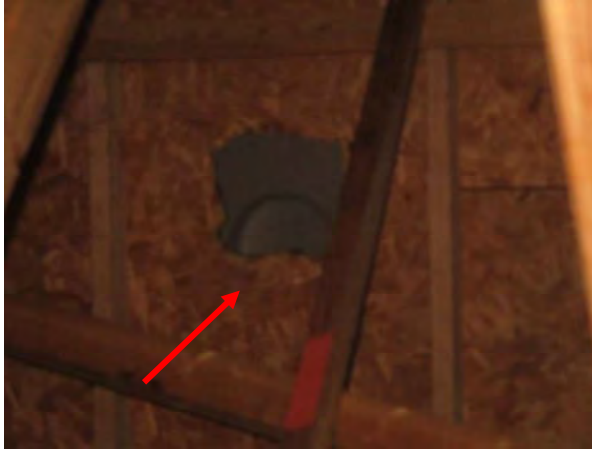
One of the attic vent(s) was observed partially covered by plywood.

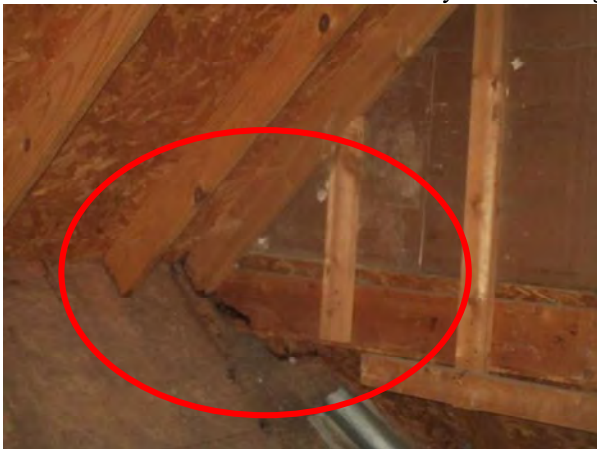
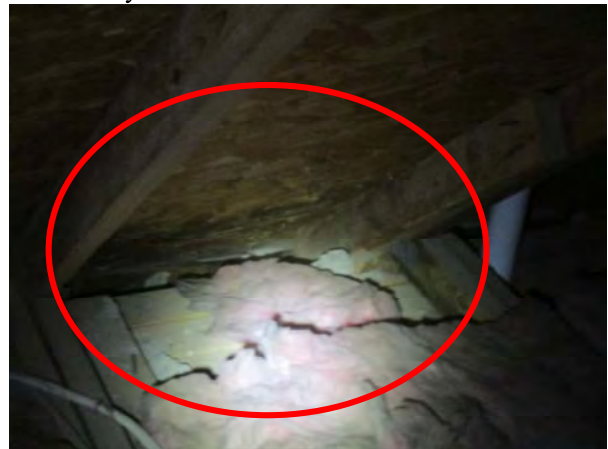
There are visible water stains on the roof sheathing (decking) and structural members in various locations. It is recommended to consult with the owner about any information they may have on this condition. For all we know this may be old damage that has been already addressed.

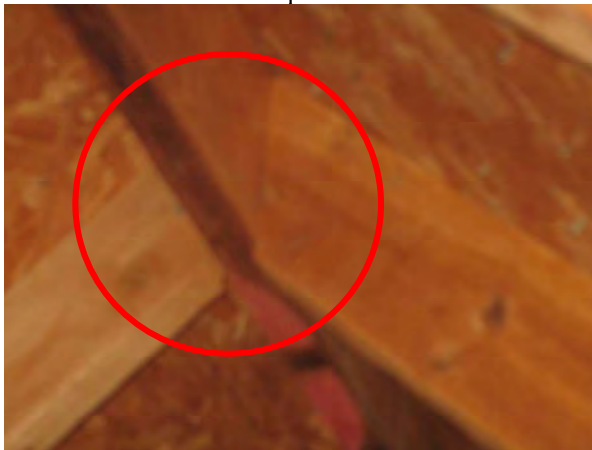
The ridge board should be the full depth of the cut rafters. This is a common observation in older homes and may have not been required at the time your house was built, although per TREC standards I am required to report this item as in need of repair.

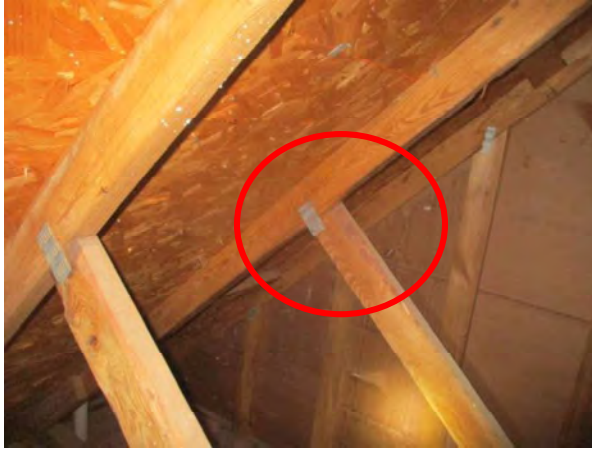
There is a damage truss gusset connection in the east area of the upper attic. This area should be investigated and/or repaired.

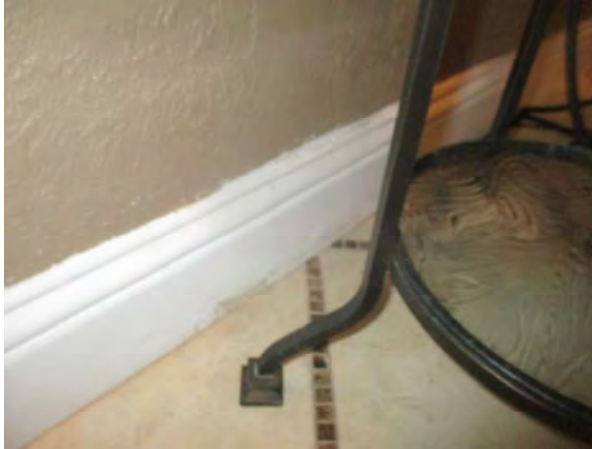
Previous water damage was observed in the upstairs hall bathroom. It is recommended to consult with the owner about any information they may have on this condition. For all we know this may be old damage that has been already addressed.

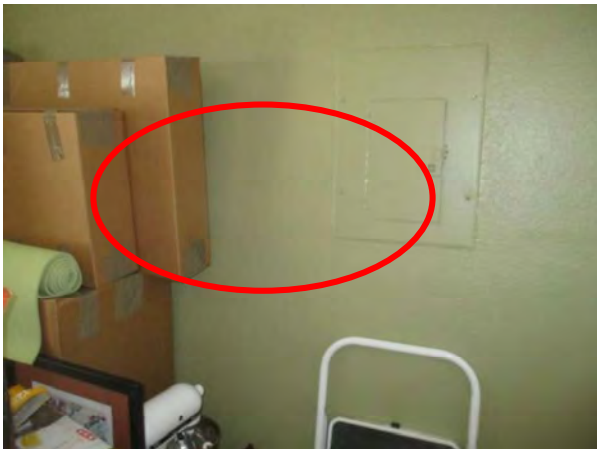
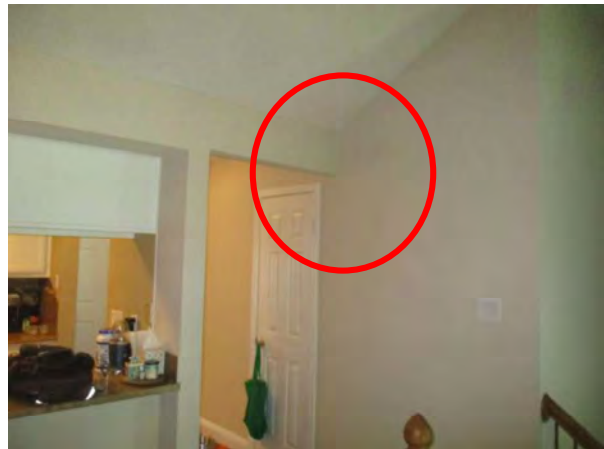
Wall sheetrock stress indicators were observed in various locations.

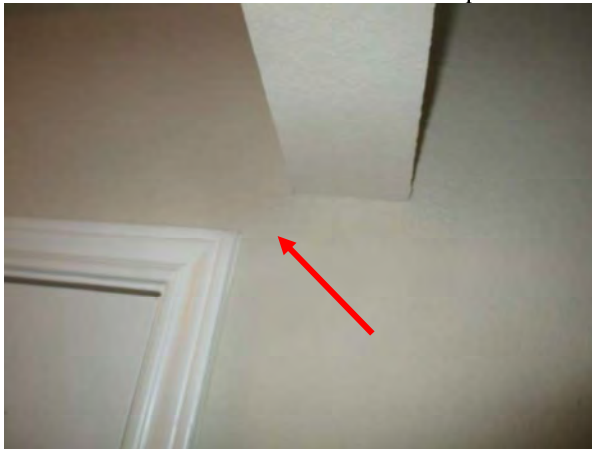
Wall sheetrock stress cracks were observed in upstairs kitchen hall.

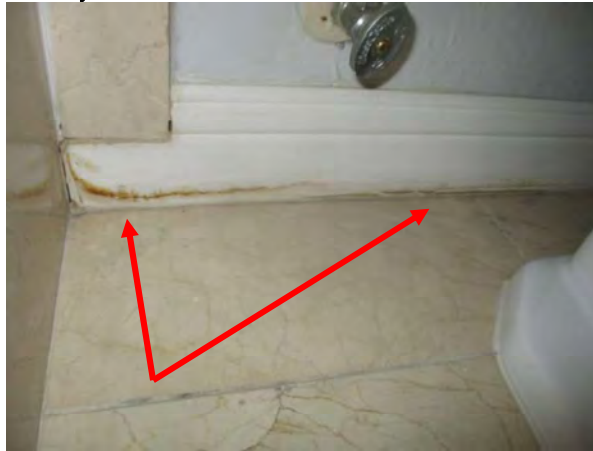
Previous water damage was observed in the master bathroom. It is recommended to consult with the owner about any information they may have on this condition. For all we know this may be old damage that has been already addressed.

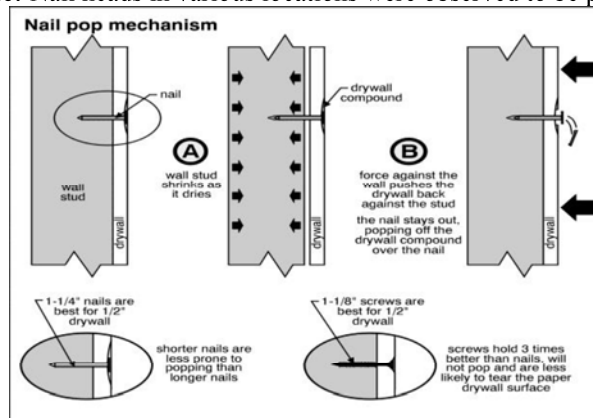
**Note:** Nail heads in various locations were observed to be pushing through the interior finish.

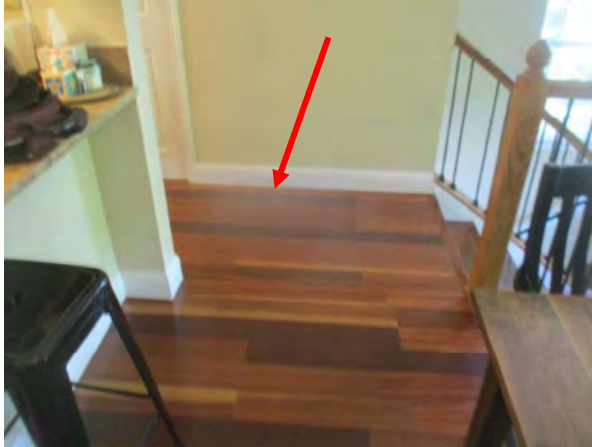
There is a soft spot in the upper hallway to the kitchen flooring. I could not determine the cause. If there are any concerns I recommend having a licensed contractor review this observation.

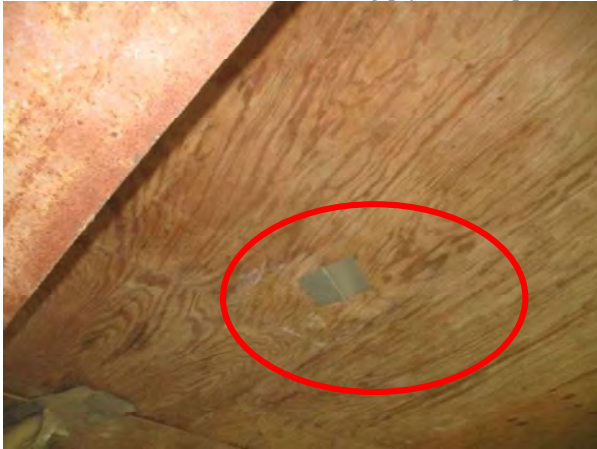
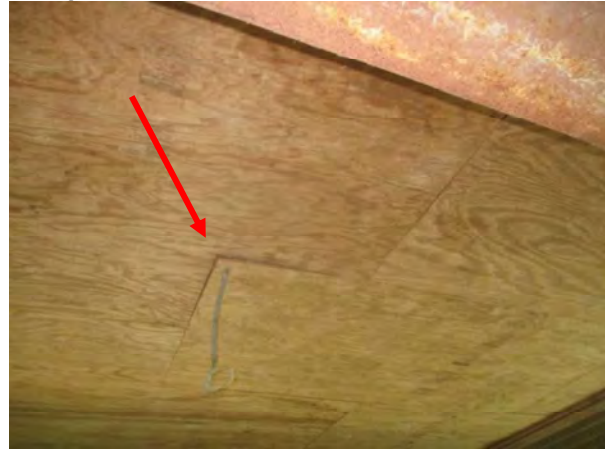
The ceiling plywood is pulled loose and is damaged under the structure.

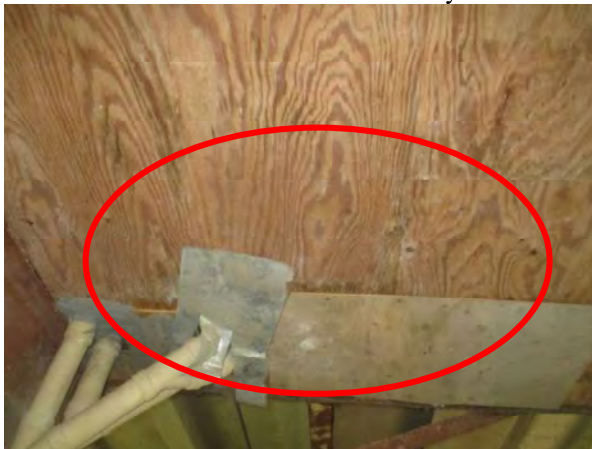
Water stains were observed on the ceiling finish material under the structure. The cause and remedy should be further evaluated and corrected as necessary.

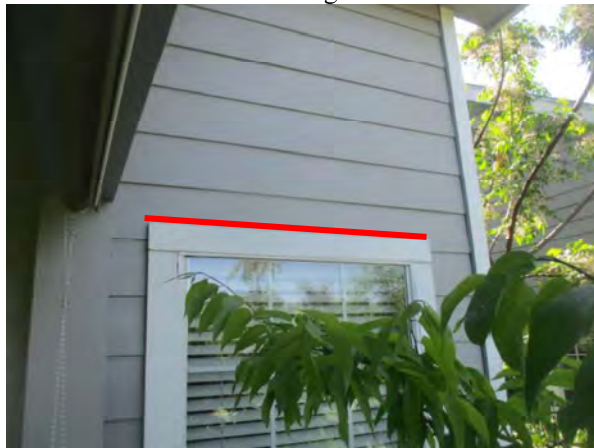
Effective flashing should be provided for all doors and window trim that projects from the wall. This is a common observation and no damage associated with its absence was observed.

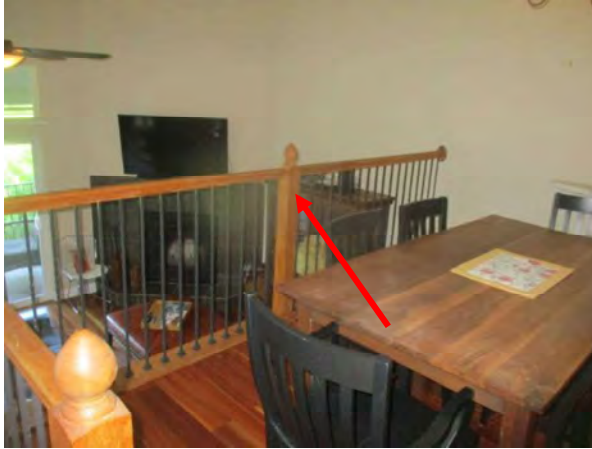
The railing and/or guardrail for the stairway is loose and should be better secured for reasons of safety.

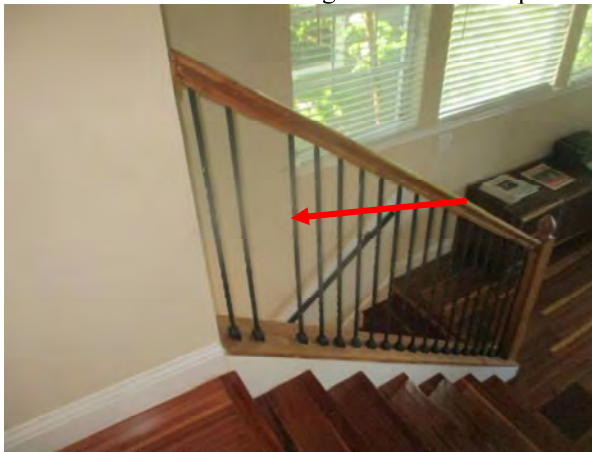
One of the stair balusters is missing and should be replaced for safety reasons.

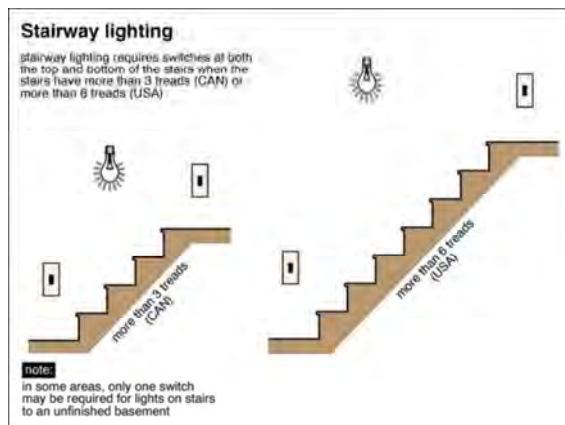
A three way switch for the stairway lighting was not present at the time of this inspection. Under current electrical standards, activation switches should be accessible at the top and bottom of the stairway without traversing any step of the stairs.

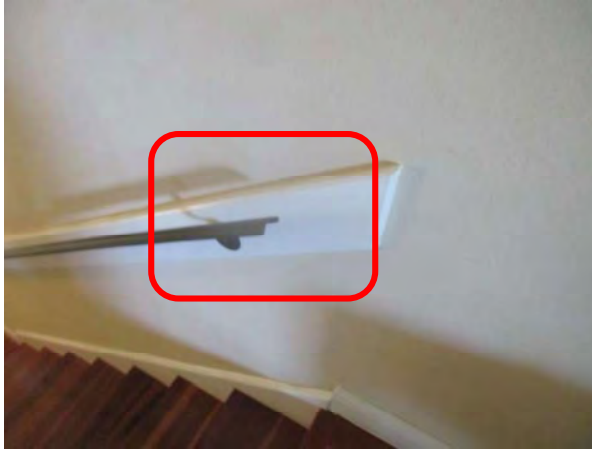
For improved safety, the handrail for the stairs should return to the wall.

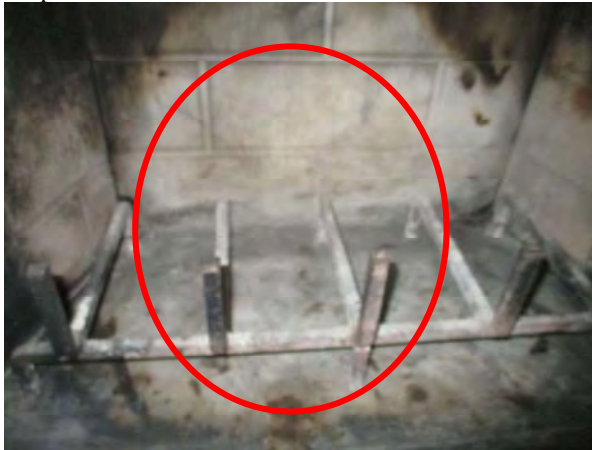
The fireplace firebox floor and rear wall is cracked should be repaired for improved safety.

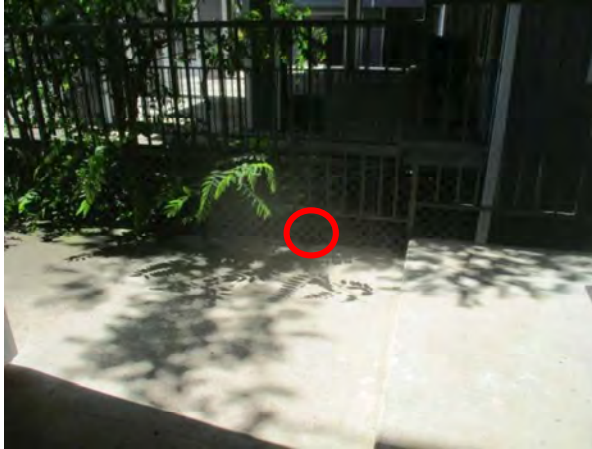
The openings in the railing are large enough to allow an object larger than four inches to fall through. *This item may have not been required at the time of construction although; per TREC standards (Texas real Estate Commission), I am required to report the lack of this item as in need of repair.*

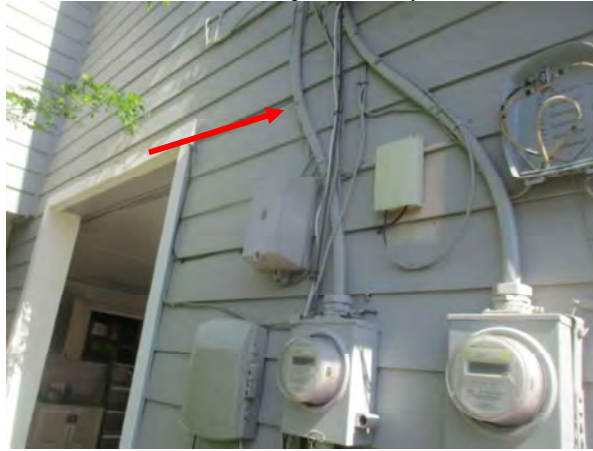
The service conductors are not protected by conduit. This is common for a home of this age.

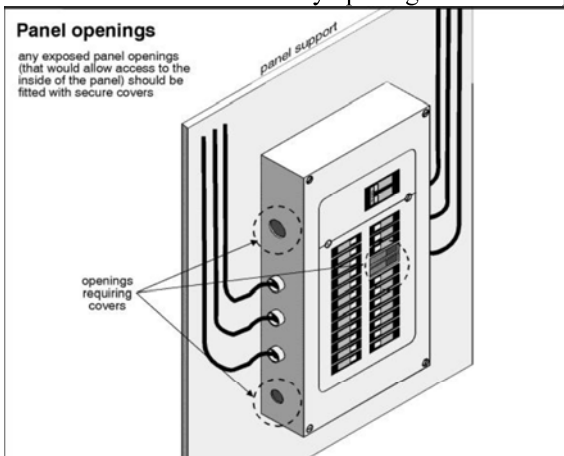
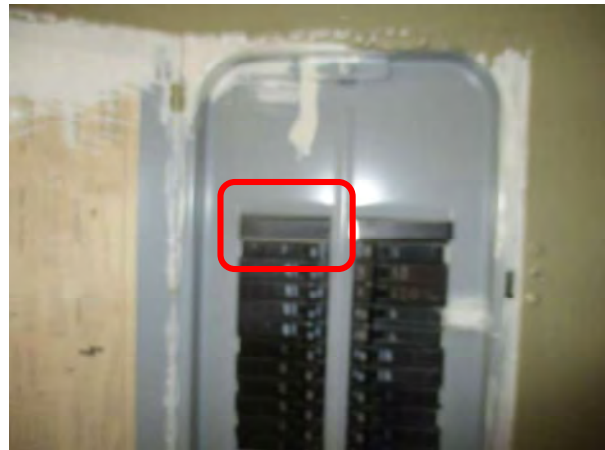
All the breakers should be properly identified.

The sub panel door is not latching.

Any openings in the main panel should be covered.

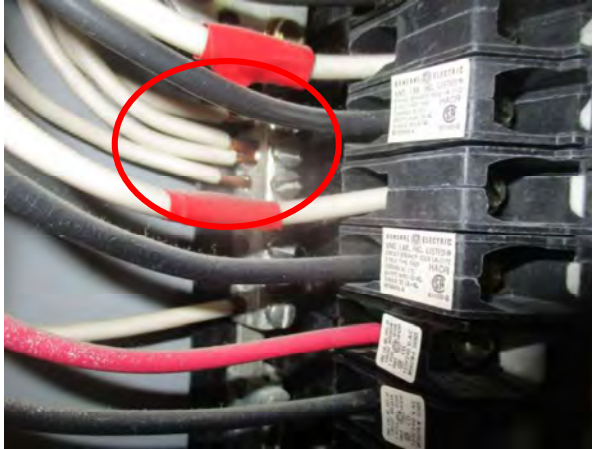
Double wired/lugged neutral wires observed in the sub panel. The arrangement is considered improper.

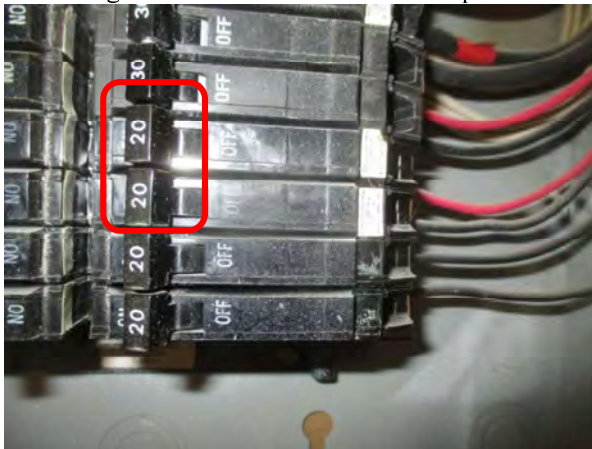
One or more of the breaker trip-ties appear to be missing. The 120V overcurrent devices (breakers) sharing a grounded conductor (Neutral) should be connected together by trip-ties. This is a common observation for a home of this age and under TREC standards of practice I must list this item as deficient.

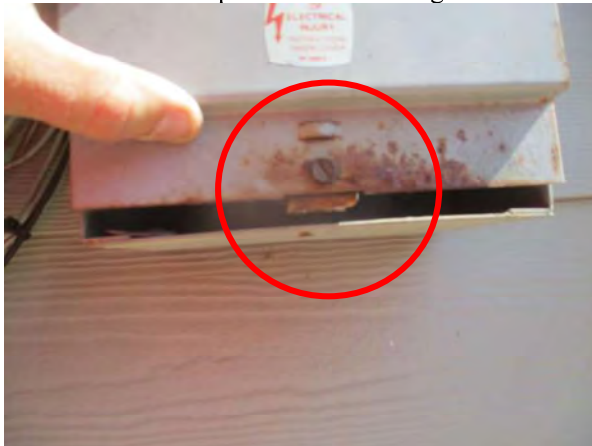
The main panel should be sealed to the structure, to help prevent water penetration.

The main disconnection panel cover is damaged

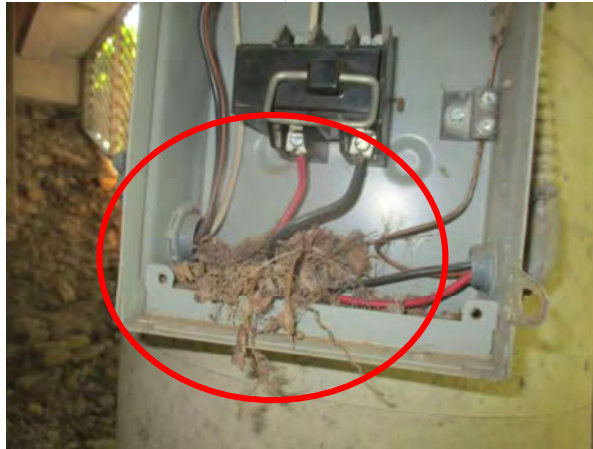
The disconnection panel for the condenser is loose and needs to be better secured.

The electrical cabinet cover plate (dead front) is missing. This should be corrected for reasons of safety.

The outside electrical cabinet ( AC disconnection) has debris that should be removed.

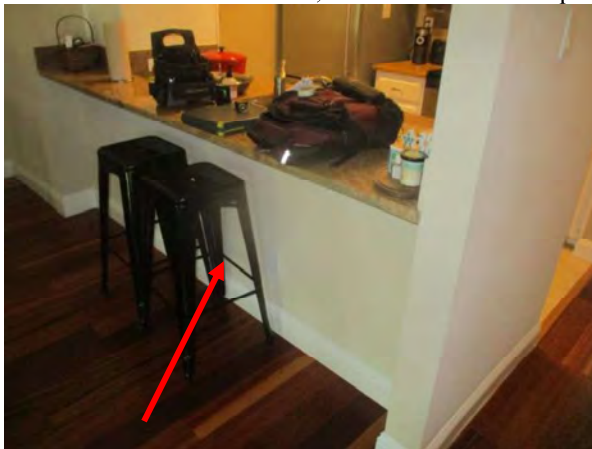
Not all of the kitchen receptacles appear to be connected to a ground fault circuit interrupter (GFCI) device. Under current electrical standards, all of the kitchen receptacles should have GFCI protection.

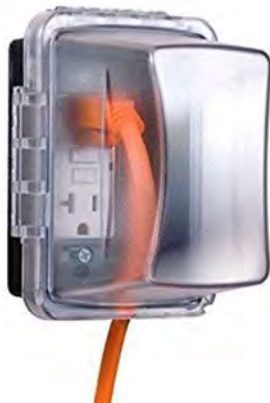
Under current standards all exterior receptacles should have rain tight protective covers.

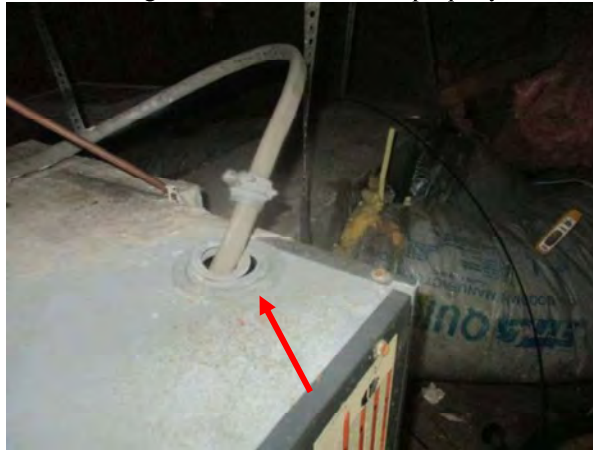
The wires entering the furnace cabinet are properly secured or protected from the sharp edges of the cabinet.

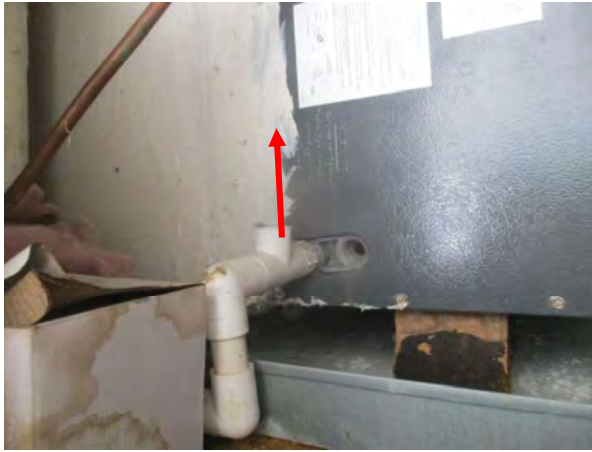
There is no drain line for the safety pan and I did not locate a safety switch for the pan. This should be further reviewed and repaired to protect from an overfilled pan.

The condensate drain line vent should be two inches above the drain.

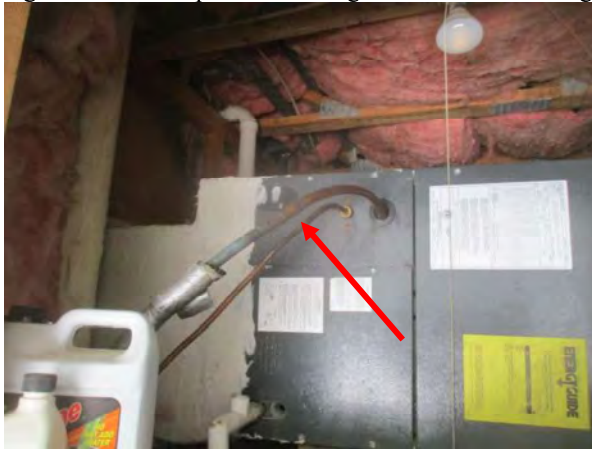
Damaged, deteriorated and/or missing insulation on the refrigerant lines at the evaporator coil should be repaired or replaced as necessary. This will keep condensate from dripping into the pan and potentially causing corrosion and possible damage to floors and ceilings.

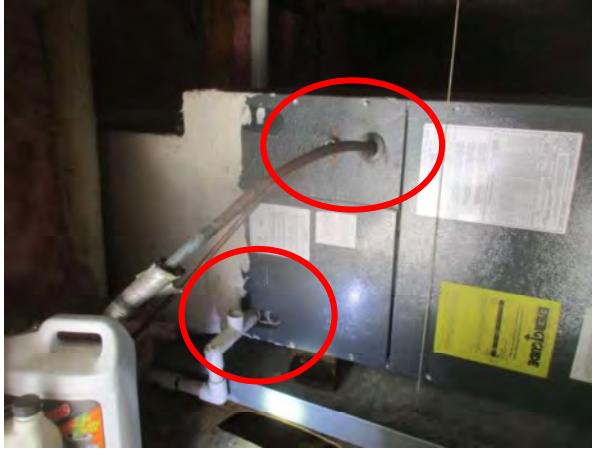
It appears the cover to the evaporator coil is not sealed and is drawing air from within the attic space. Recommend repair by a licensed HVAC technician.

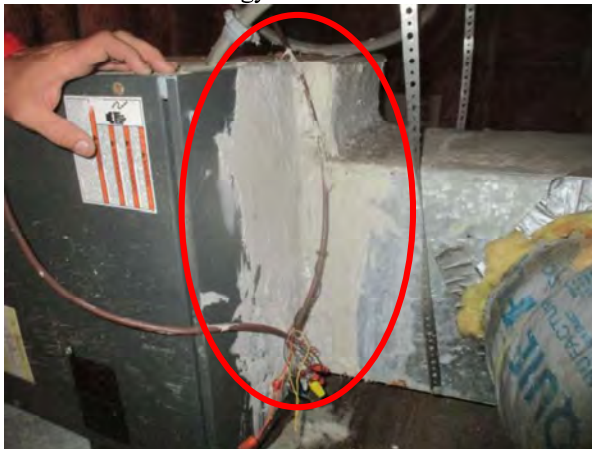
There is air leaking where the supply air plenum attaches to the air handler. This improvement is a minor repair and will reduce energy costs.

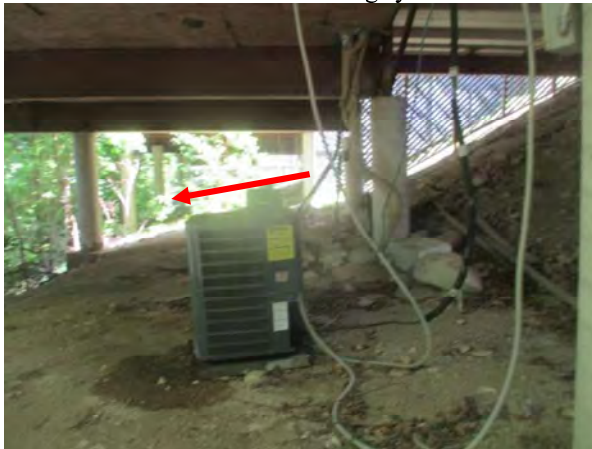
The outdoor unit of the air conditioning system is out of level. This should be improved.

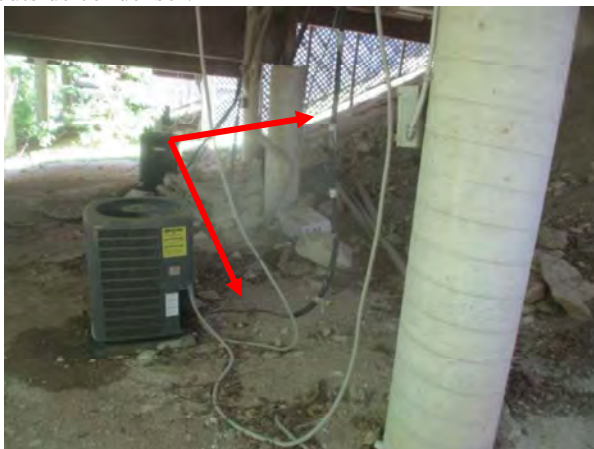
Damaged, deteriorated and/or missing insulation on the refrigerant lines should be repaired or replaced at the outside condenser.

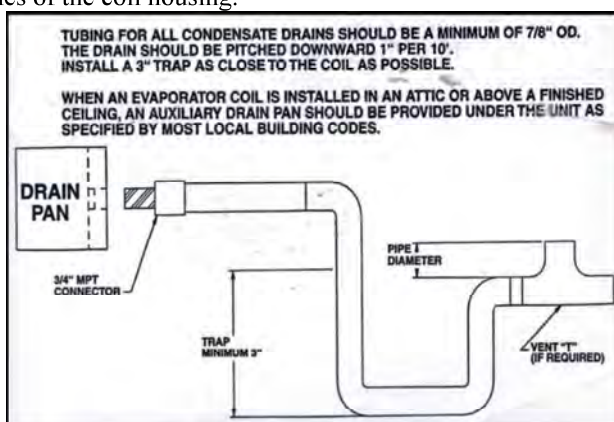
The primary condensate drain lines are not equipped with a p-trap. Under current mechanical installation standards, the manufacturer requires a p-trap be installed in the primary condensate drain line within 6-inches of the coil housing.

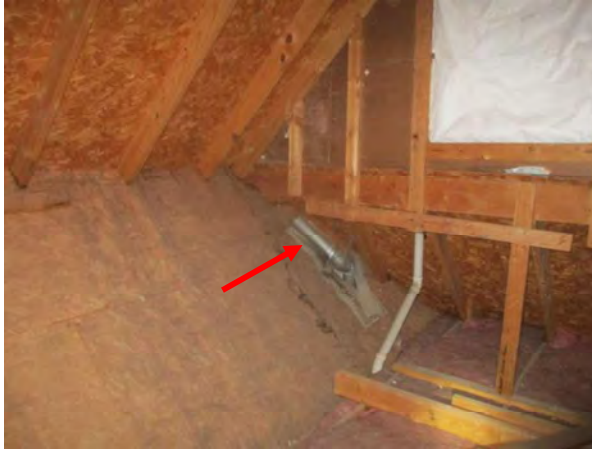
There is an unidentifiable vent terminating in the upper east attic

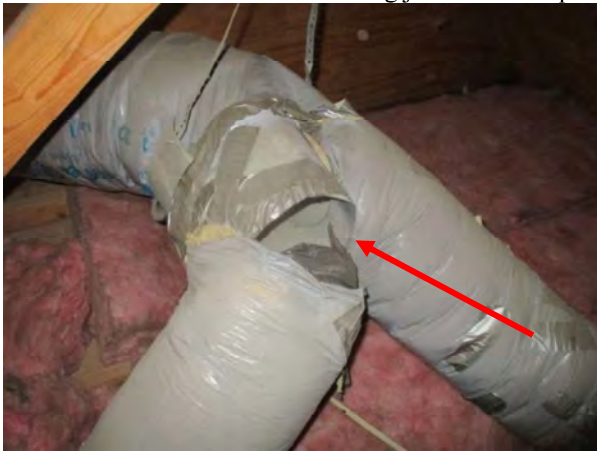
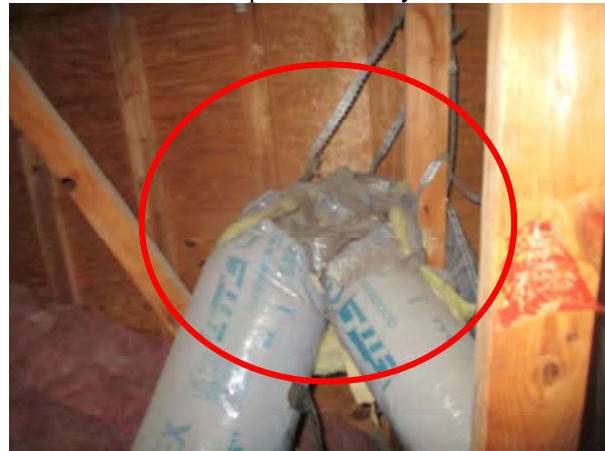
Loose fitting joints and/or openings in the ductwork should be improved at many locations.

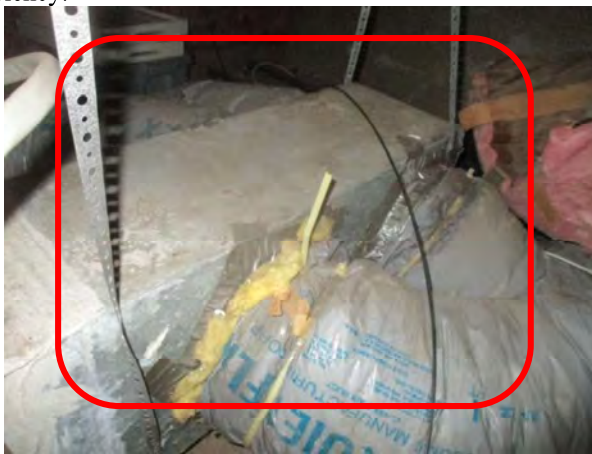
The ducts are leaking air where they attach to the supply plenum. This should be repaired to improve efficiency.

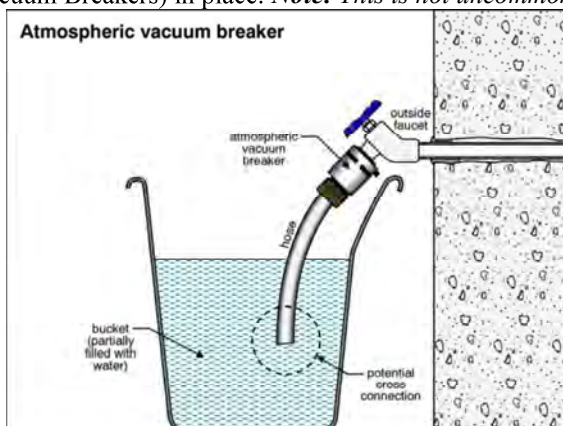
Various hose bibbs are loose and should be secured.

One or more of the exterior water hose bibbs (faucet) do not have a back-flow or anti-siphon device (Vacuum Breakers) in place. **Note:** *This is not uncommon to observe with a home of this age.*

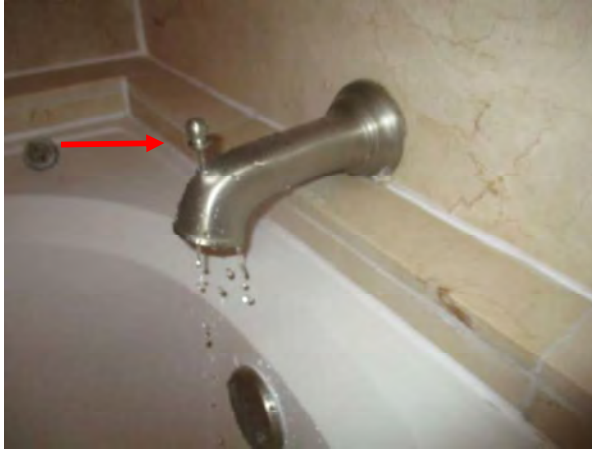
The bathtub shower head diverter leaks at the tub faucet when on.

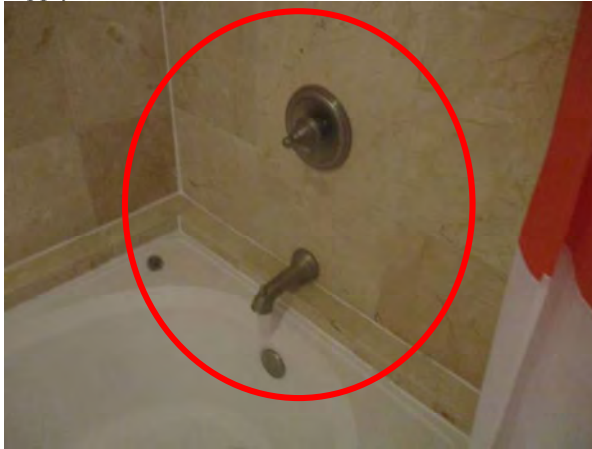
The supply valves and faucet for the shower/tub should be sealed to the enclosure.

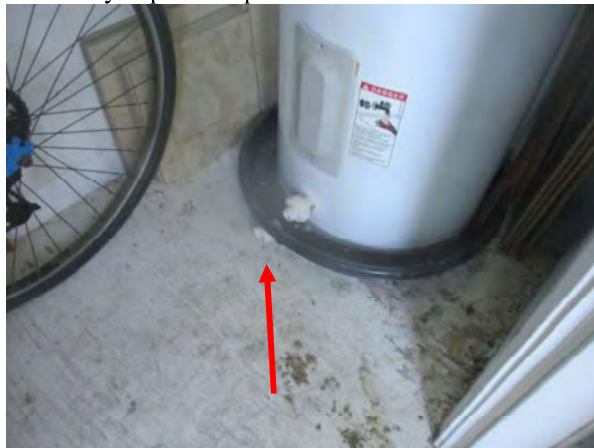
No safety pan and drain was found for the water heater. This should be repaired by the installation of a pan with a drain by a qualified professional

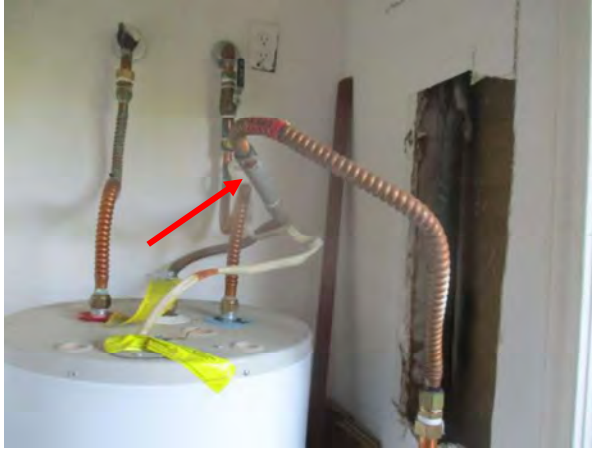
The temperature and pressure relief (TPR) valve discharge pipe is running in an upwards direction in one or more locations. The TPR discharge pipe should run gravitationally downwards at all points.

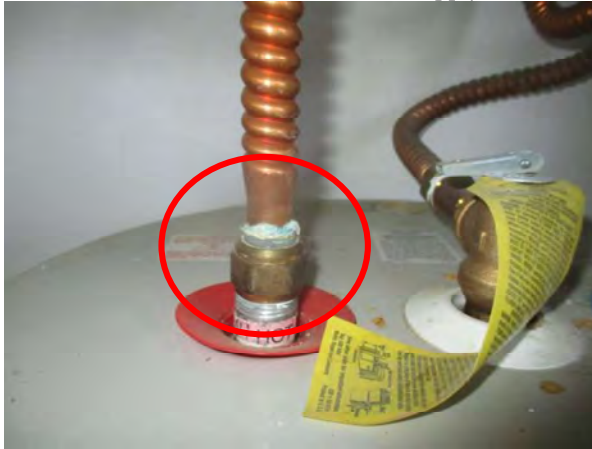
Some corrosion was observed at the water supply connections at the top of the water heater.

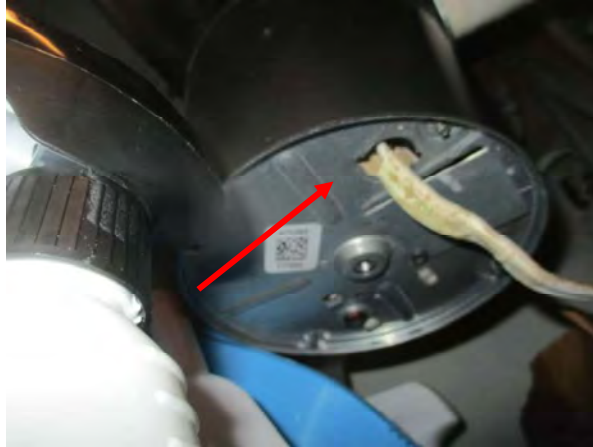
Wiring serving the food waste disposer should be protected by a conduit.

The wires entering the disposer are not properly secured or protected from the sharp edges.
