Nunnallee Inspections

Condo with Termite Inspection

Sample Inspection Report

PROPERTY INSPECTION REPORT

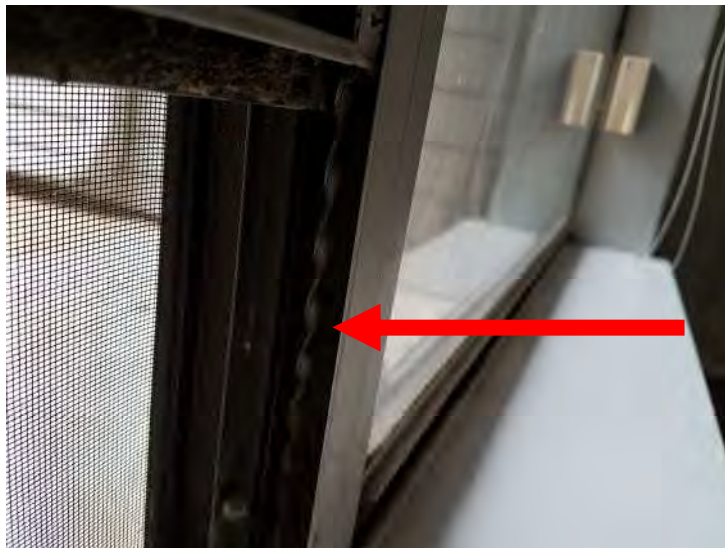
The spiral balancer for a window(s) in various locations is damaged and in need of repair.

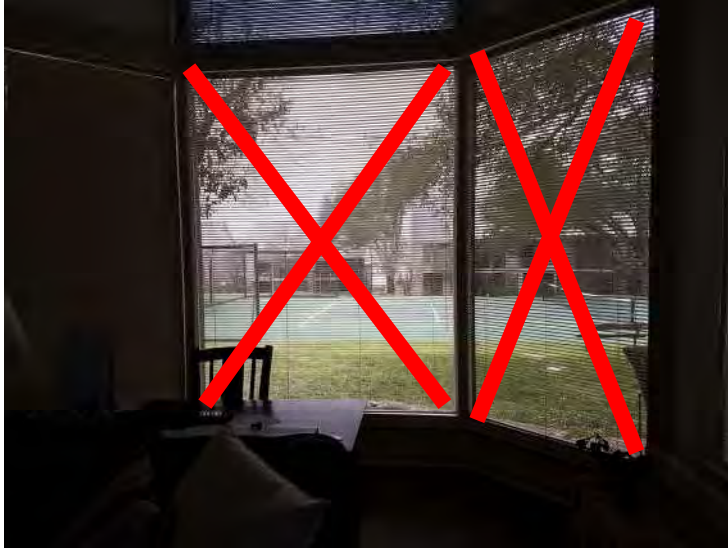
(Under current building standards the following are considered hazardous locations that require safety glass.)

Glass in individual fixed or operable panels within 18-inches of the floor.

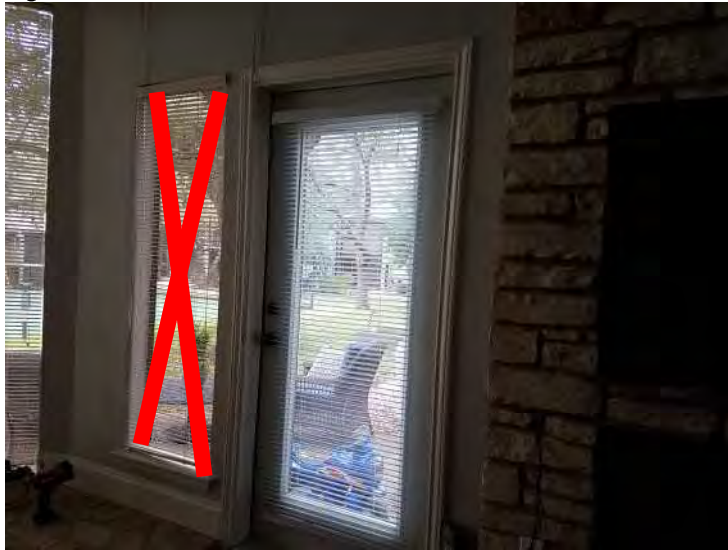
Glass in an individual fixed or operable panel adjacent to a door where the nearest vertical edge is within a 24-inch arc of the door in a closed position and whose bottom edge is less than 60-inches above the floor or walking surface.

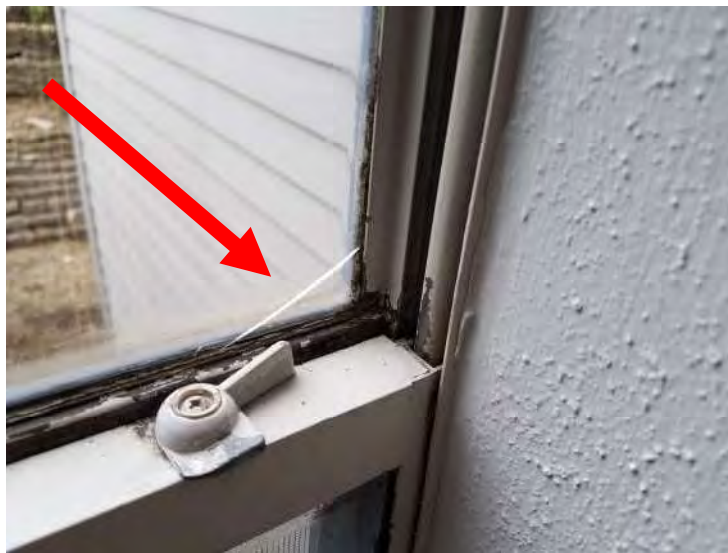
The window(s) adjacent the front door was observed to be broken or cracked.

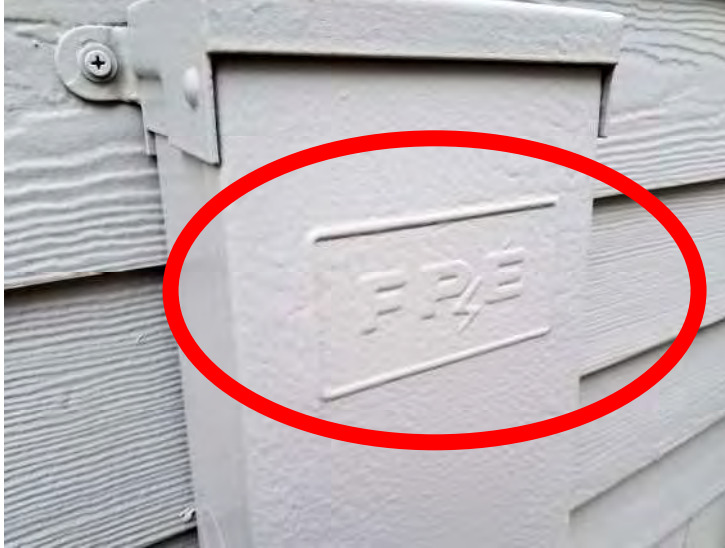
Notice: There is a Federal Pacific panel box in place at the time of the inspection. This panel box is known to have various problems and/or deficiencies. Full evaluation of this panel box is beyond the scope of this inspection. You are encouraged to have the panel box further evaluated by a qualified electrician prior to closing.

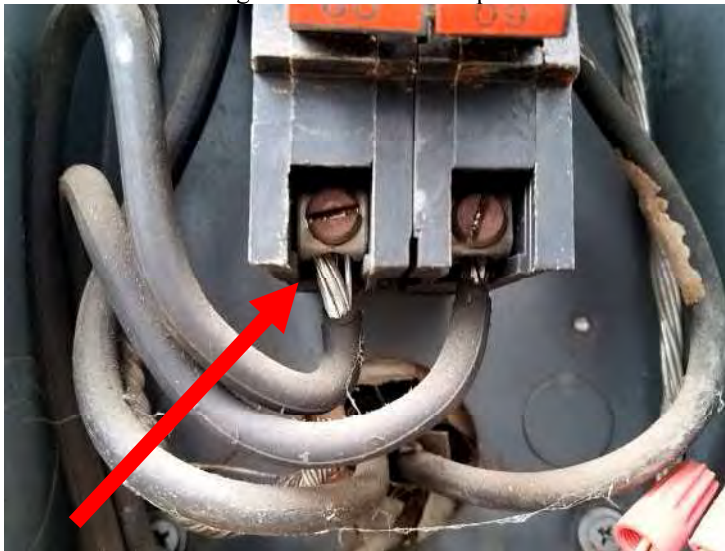
The breaker serving the A/C compressor is oversized. Under current electrical standards, this is no longer an acceptable practice. *This item may have not been required at the time of construction although; per TREC standards (Texas real Estate Commission), I am required to report the lack of this item as in need of repair.* There was no anti-oxidant gel observed on the exposed aluminum conductor terminations.

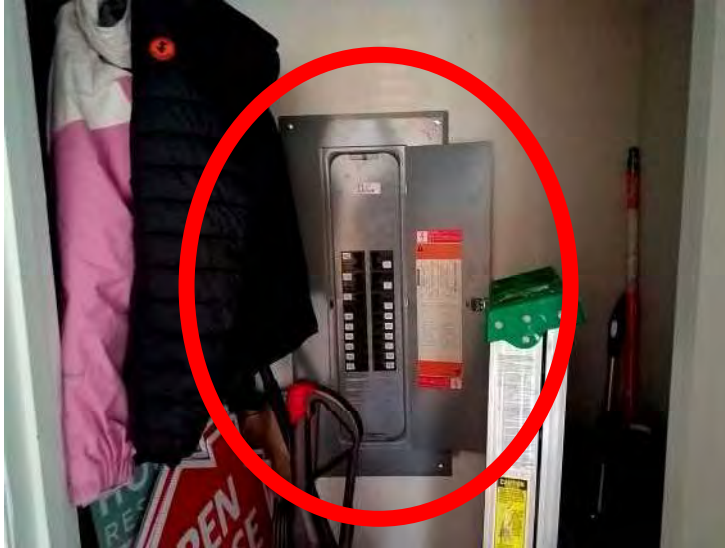
The electrical panel is located in a clothes closet. Under current electrical standards, this is no longer an accepted practice. This is an “as-built” condition but Per TREC standards of practice we are required to report this condition as a deficiency.

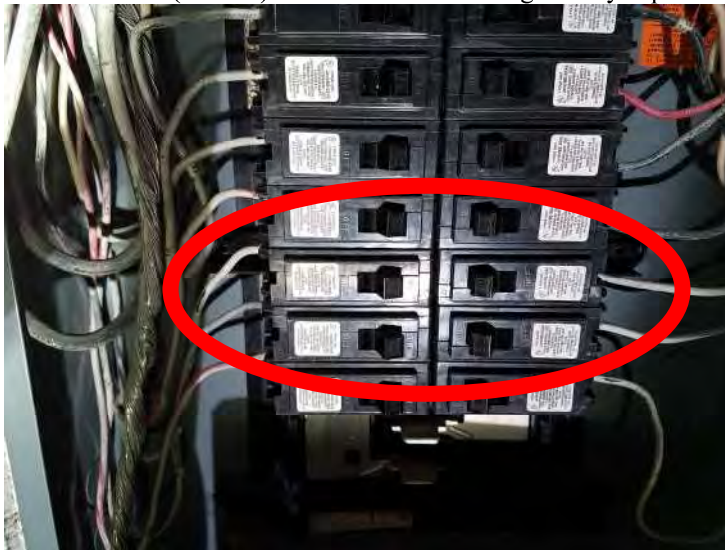
One or more of the breaker trip-ties appear to be missing. The 120V overcurrent devices (breakers) sharing a grounded conductor (Neutral) should be connected together by trip-ties.

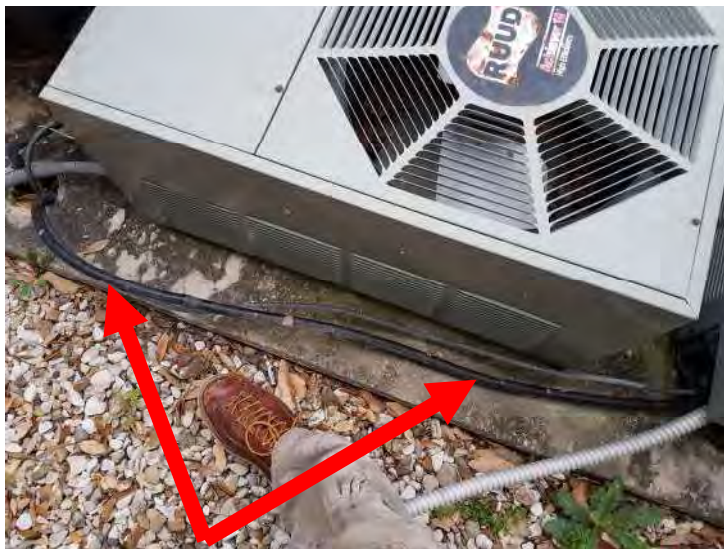
Damaged, deteriorated and/or missing insulation on the refrigerant lines should be repaired or replaced at the outside condenser.

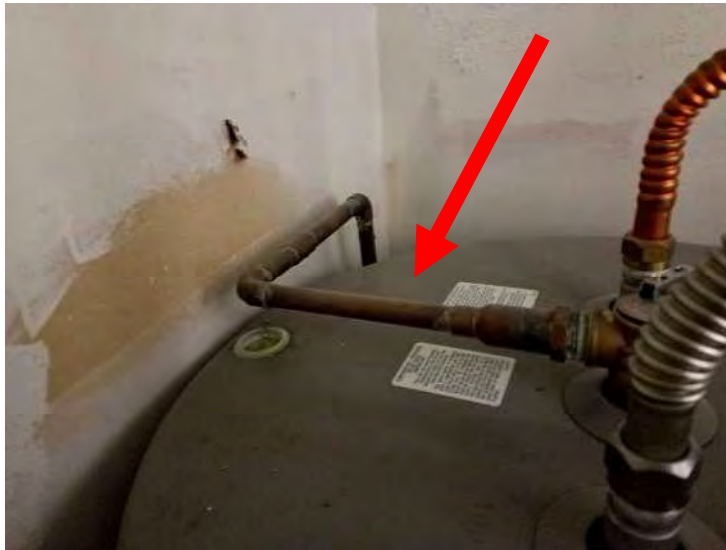
The temperature and pressure relief (TPR) valve discharge pipe has been downsized. The TPR discharge pipe should be no smaller than 3/4-inch at any point.

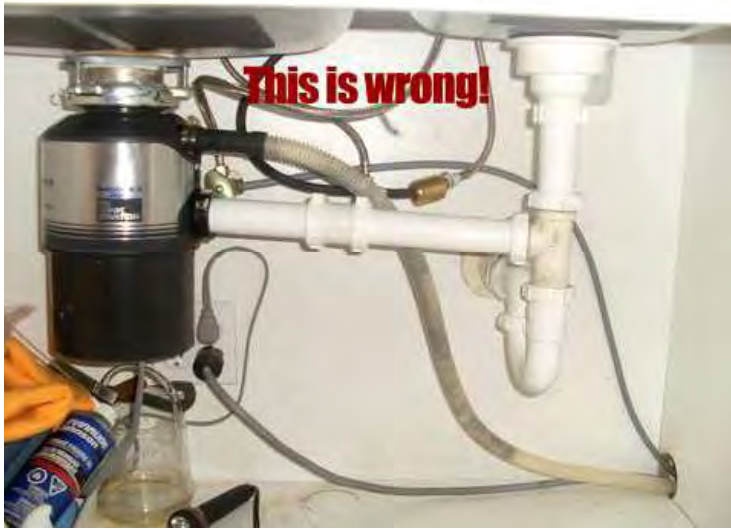
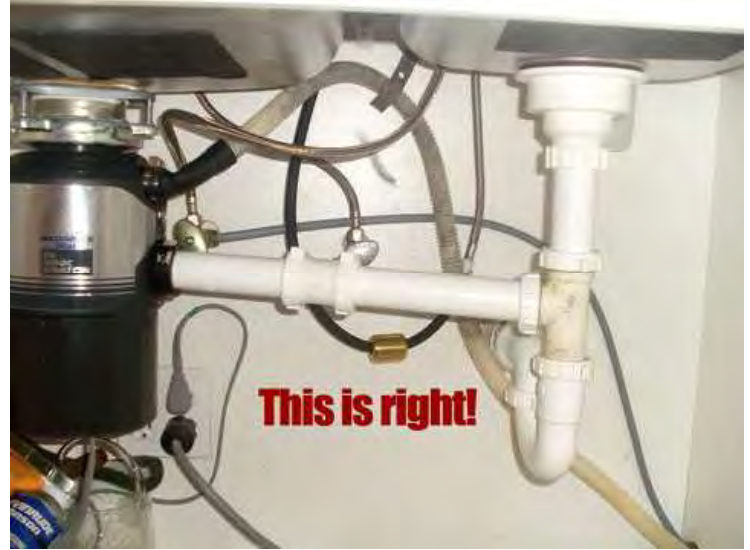
The dishwasher drain hose is not properly installed to prevent back flow or anti-siphoning. It is recommended that an air gap device be installed in the drain line or create a loop so the drain slopes down to the tail piece. This can be accomplished several ways and is simple to perform.

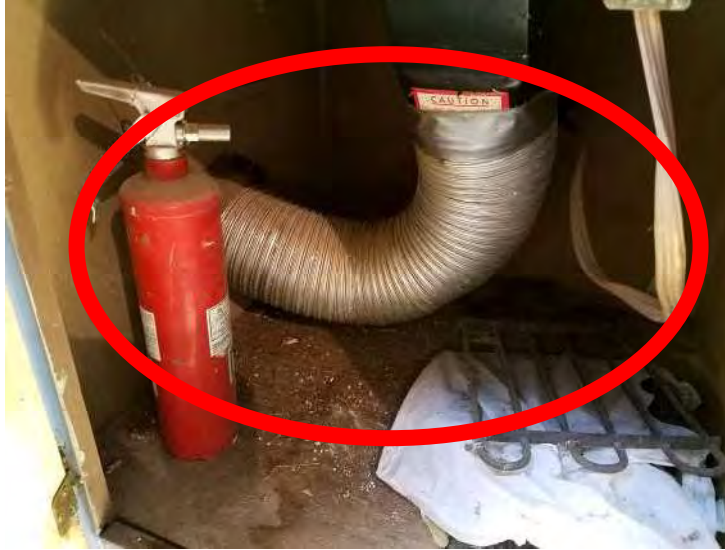
The material used for the range hood venting is improper. A smooth walled interior vent is required for this application.

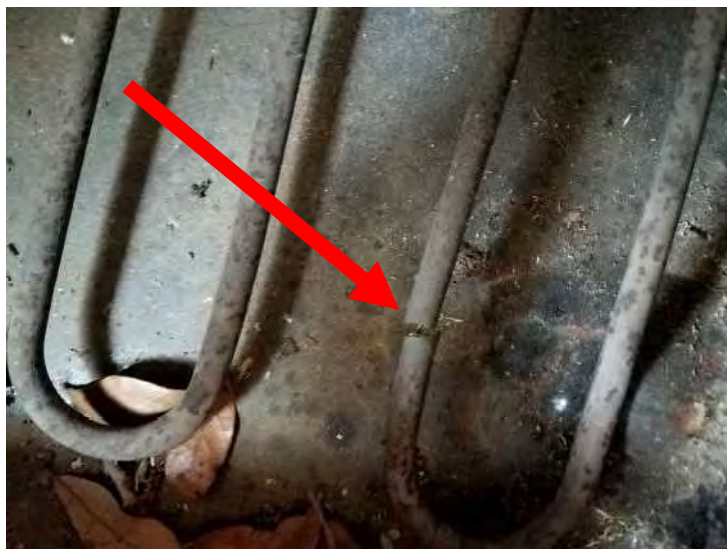
A control knob on the electric cooktop is damaged and should be repaired.

A burner on the electric cooktop is damaged and should be repaired.

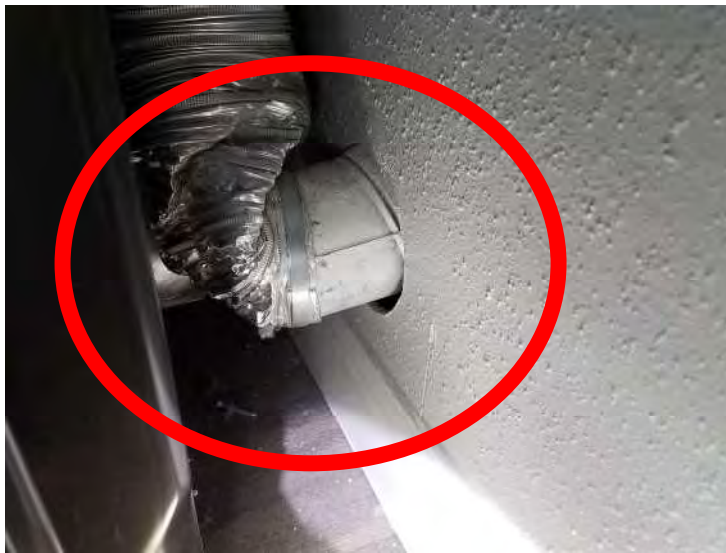
The dryer vent was observed to be crimped and is in need of adjustment.
