# Nunnallee Inspections

*Residential with Pool Inspection*

# PROPERTY INSPECTION REPORT

Concerning: Residential with Pool Inspection

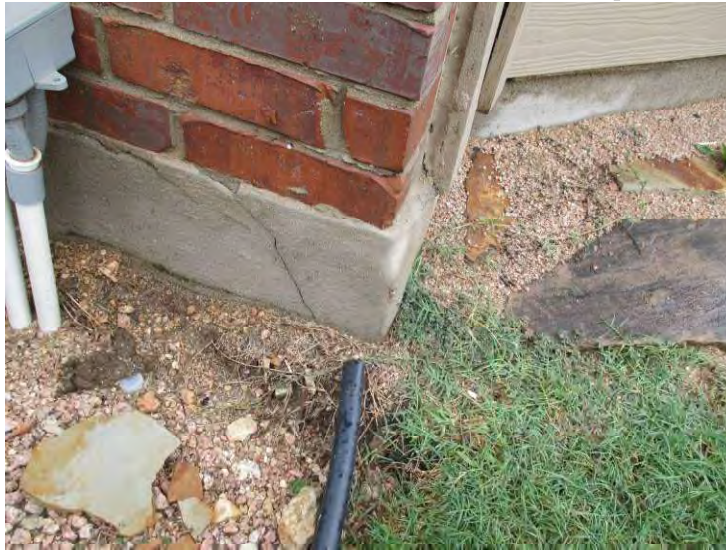
One or more of the foundation perimeter beam corners were observed to be sheared off (corner pop). This is a common condition in slab on grade foundations. This condition does not adversely affect the performance of the foundation. However, in some cases, some cosmetic improvements may be desired.

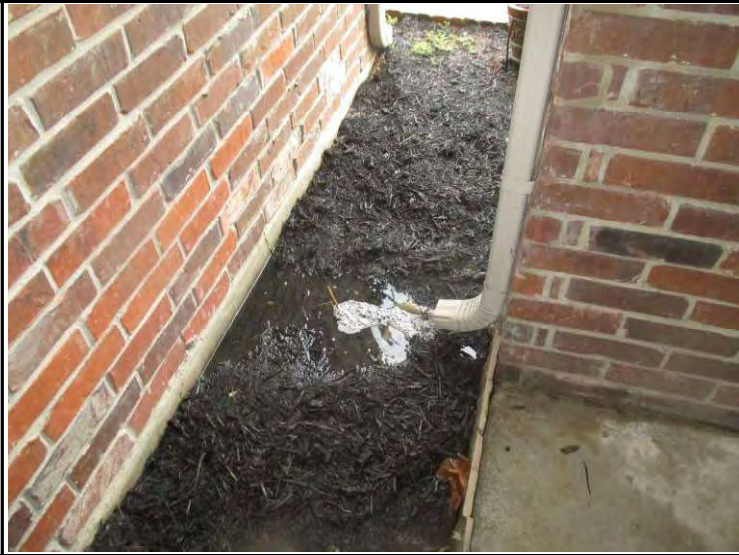
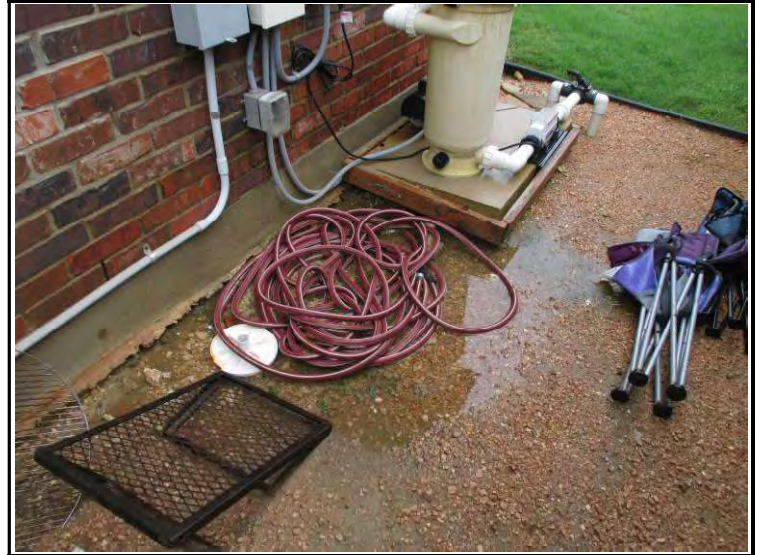
Poor to negative site drainage was observed at the front and east sides of the house. Proper drainage is needed to help prevent water from standing and/or ponding next to the foundation beam. Corrective measures may be needed if the water stands within 10-feet of the foundation perimeter beam for more than 24-hours.

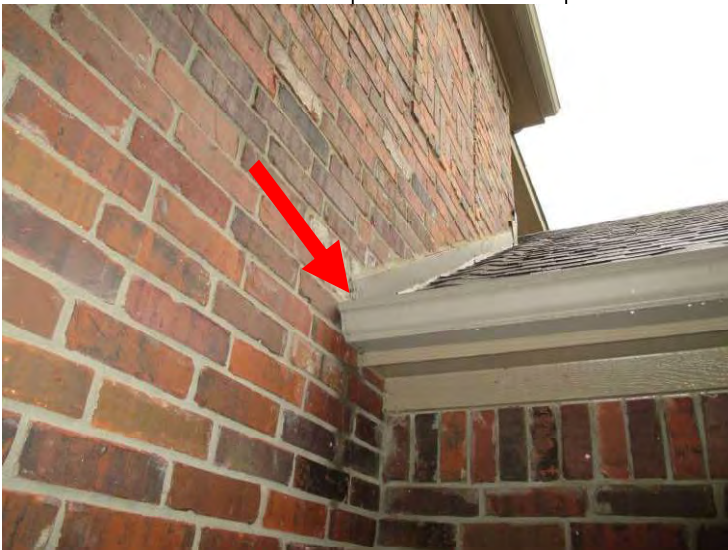
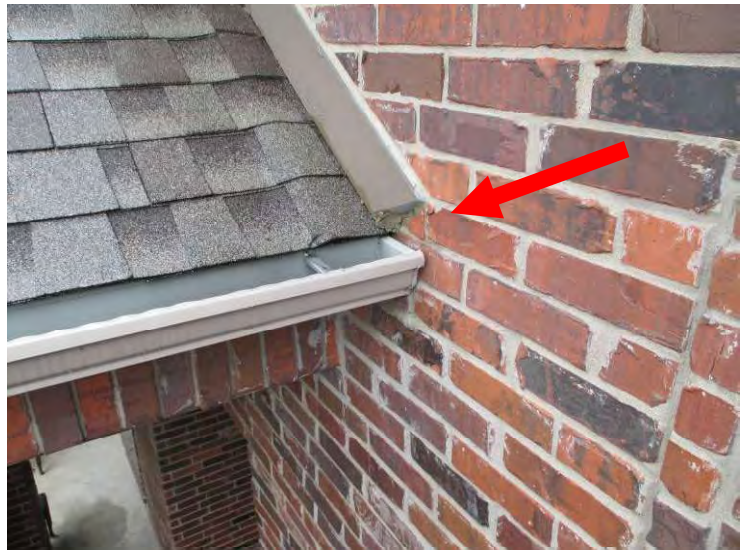
There was no kickout flashing detail observed at the lower bottom edge of the roof line interface and the sidewall that continues past the edge of the roof. The lack of this kickout flashing can allow water staining or penetration at these points.

There was no kickout flashing detail observed at the lower bottom edge of the roofline interface and the sidewall that continues past the edge of the roof. The lack of this kickout flashing can allow water staining or penetration at these points.

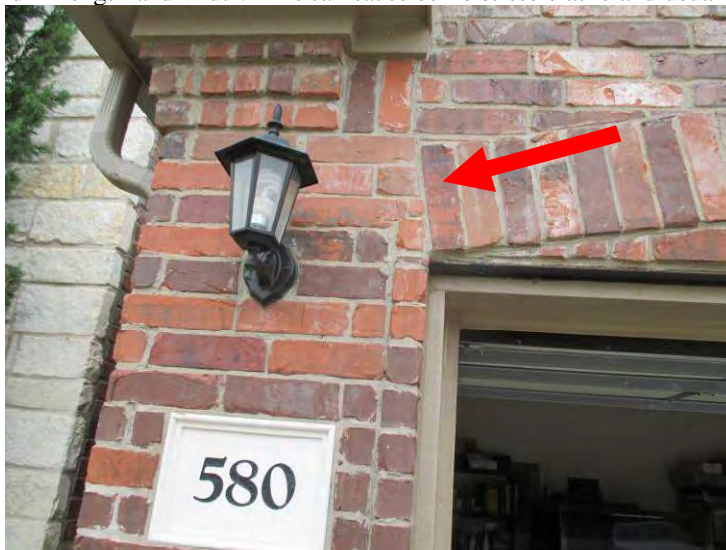
Minor cracks in the stone/brick veneer were observed. The lintel above the garage door is steel and will expand in length and width. This can cause some stress cracks and usually is not a concern.

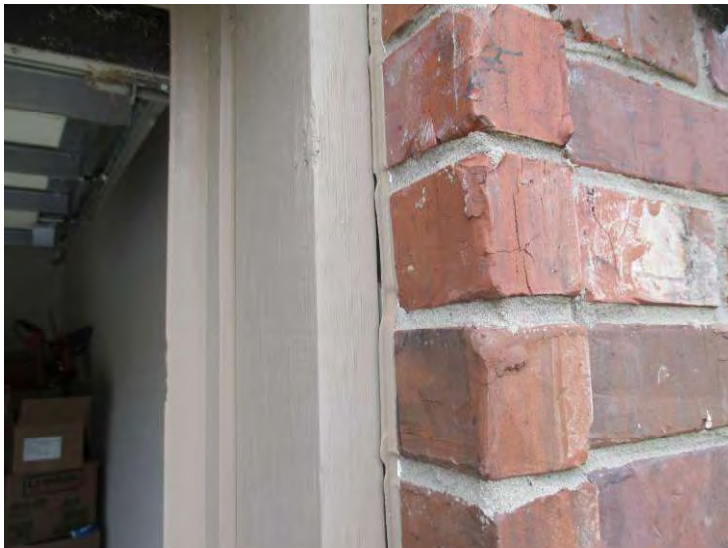
Caulking improvements are recommended for the area between the exterior veneer and the garage door trim boards.

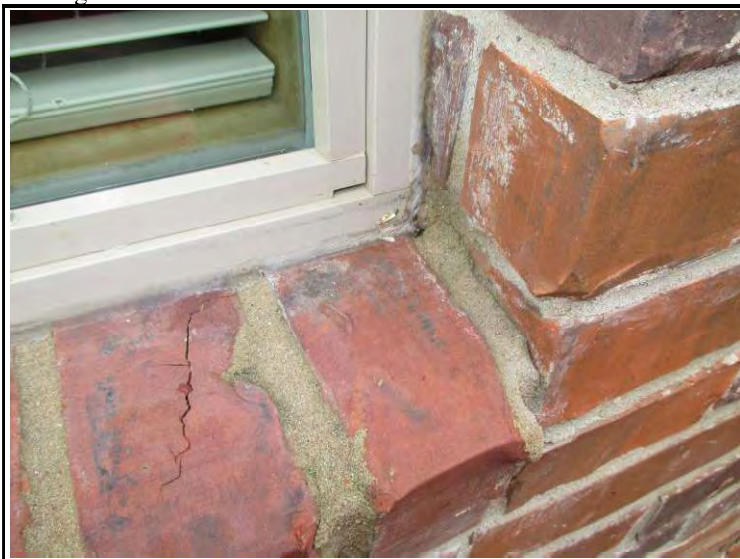
Gaps in the exterior veneer should be sealed in various locations to prevent water infiltration. This is an aspect of regular home maintenance.

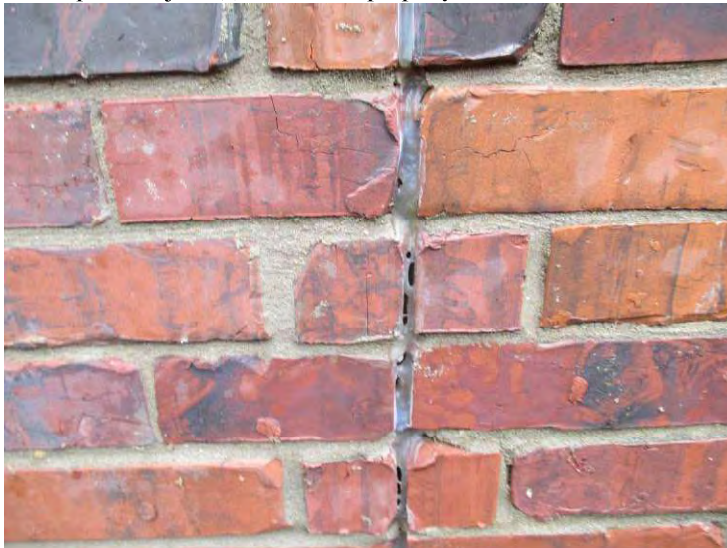
The wall expansion joint(s) need to be properly sealed on the sides of the house.

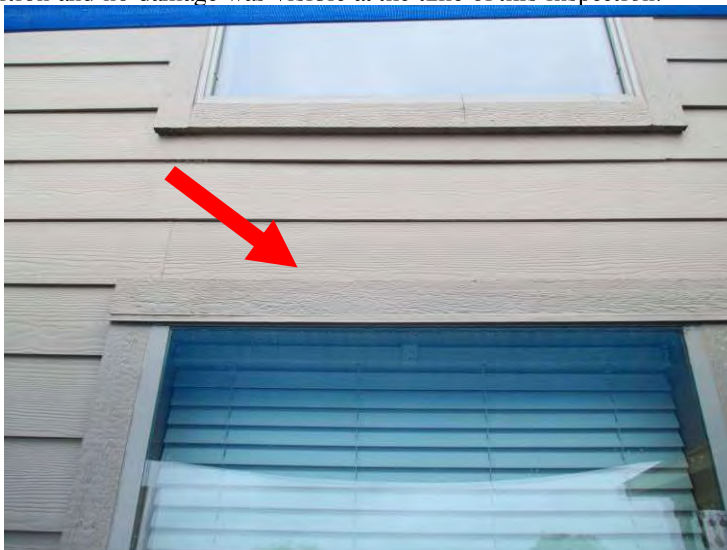
Effective flashing should be provided for all wood trim that projects from the wall. This is a common observation on many homes and may not have been required when this home was built. This is an as-built condition and no damage was visible at the time of this inspection.

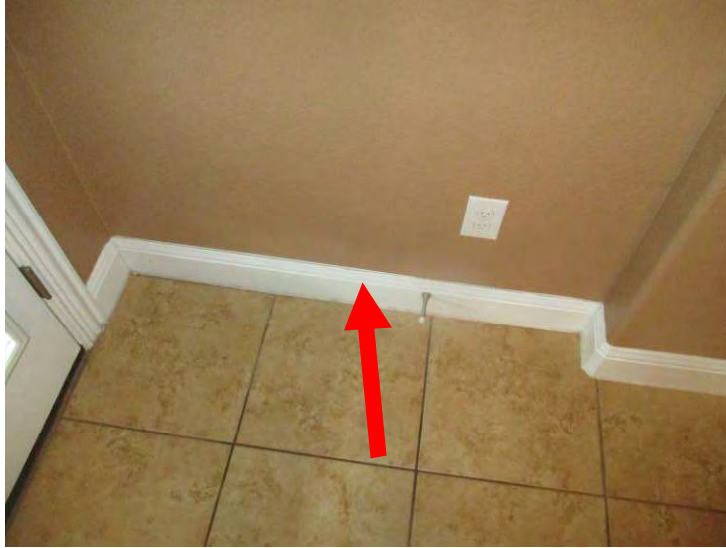
The baseboard was observed to be separating from the wall in the breakfast area.

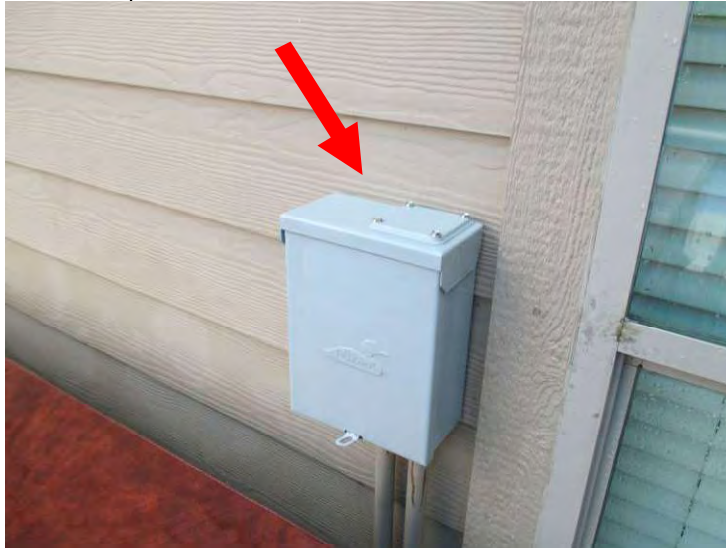
The outside sub-panel box at the hot tub should be sealed to the structure and openings sealed as necessary.

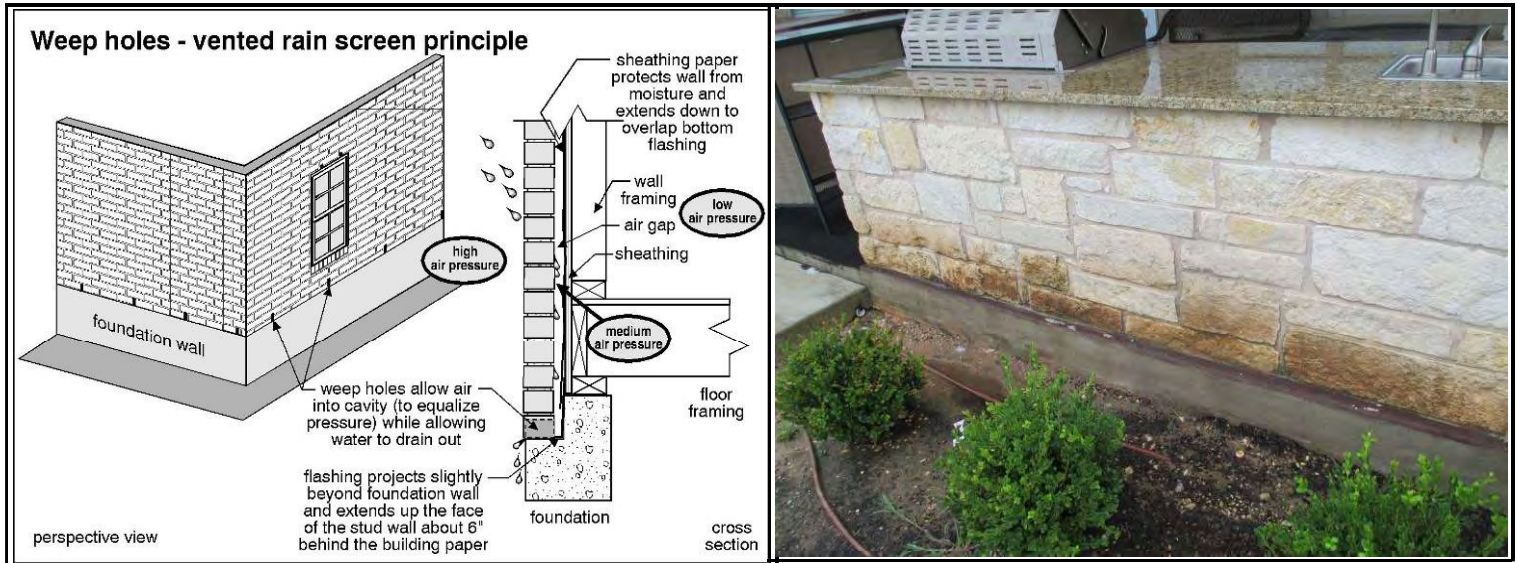
There were no weepholes observed in the lower course of the masonry veneer on the outdoor kitchen counter.

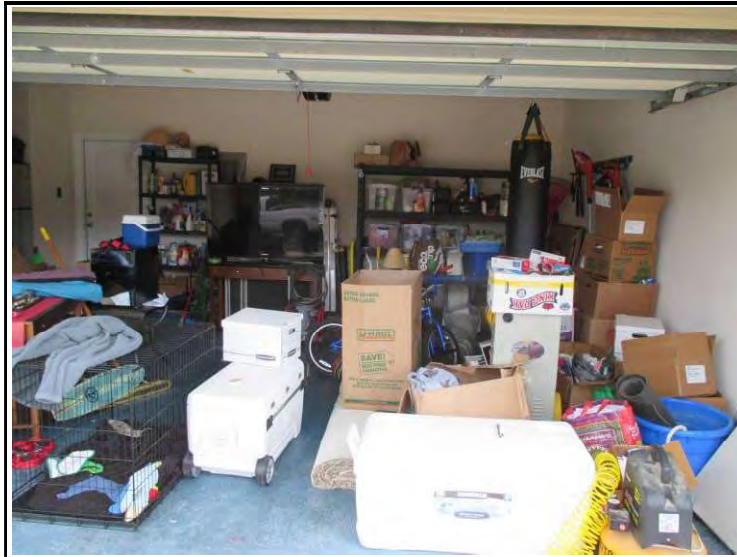
There was considerable storage observed in the garage. Some areas were not accessible at the time of this inspection.

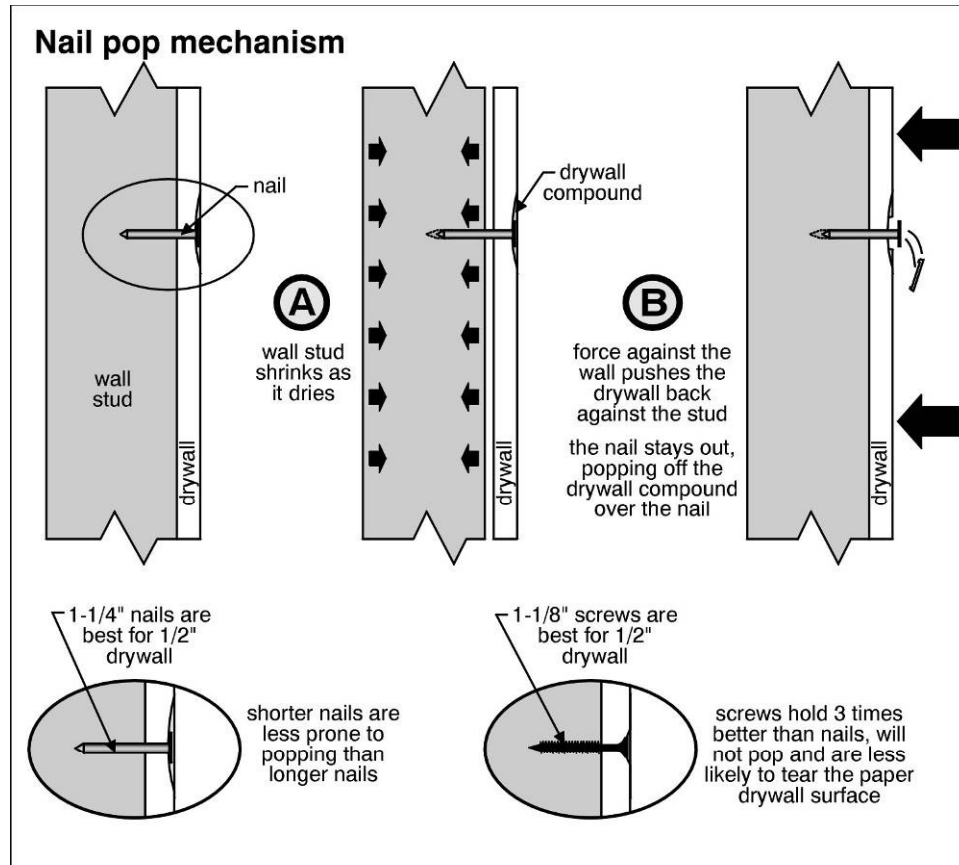
☒
☐
☐
☒
**F. Ceilings & Floors***Comments:***Note:** Nail heads were observed to be pushing through the interior finish.

Note: Nail heads were observed to be pushing through the interior finish.

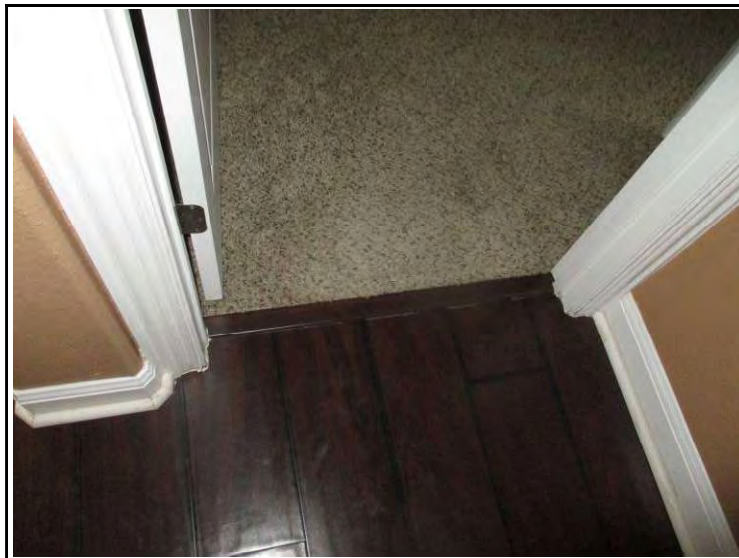
The floor trim at the master bedroom is loose and should be re-secured.

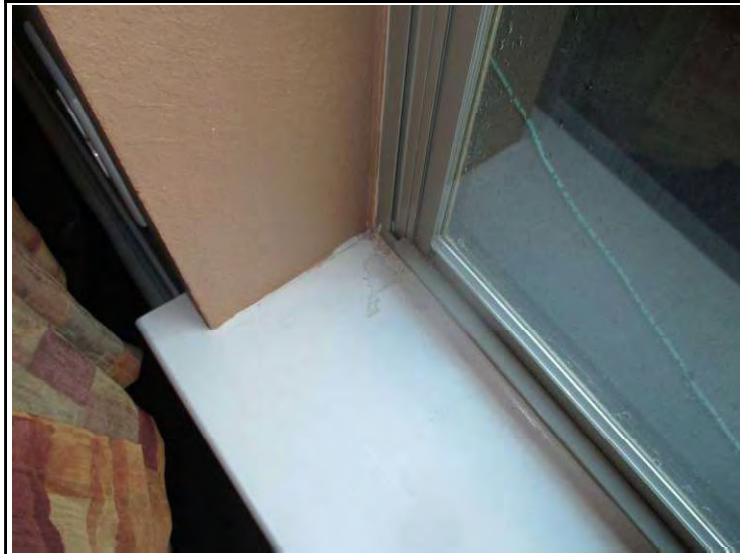
Water staining was observed at the window stools in various locations. This is usually the result of condensation on the insides or the frames of the windows.

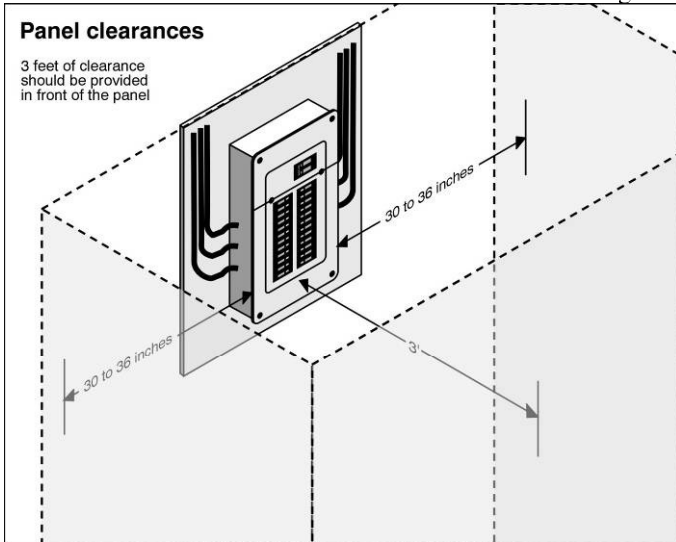
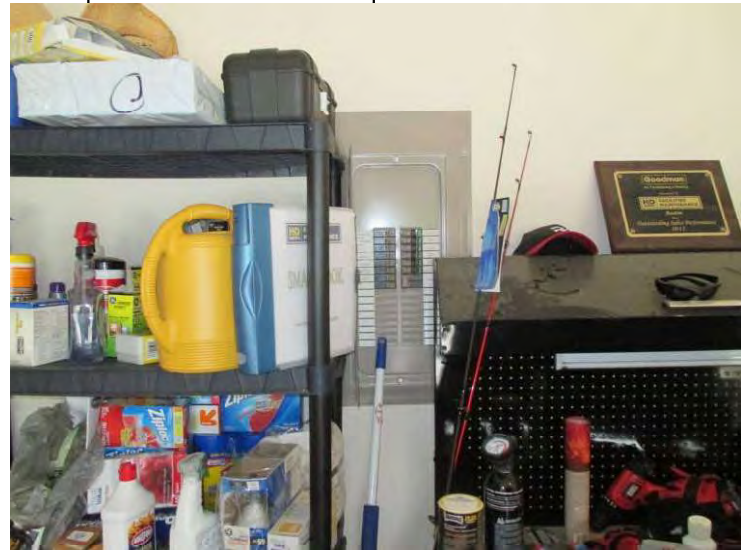
*Box Location: West Exterior Wall*

The panel box cover plate (Dead Front) and/or cabinet should be readily accessible and cover easily removable at all times. Under current electrical standards, the accessible workspace around the panel box should be at least 36-inches in depth in front of the cabinet and 30-inches in width or the width of the equipment. Clothes, shelves, cabinets, foliage, etc should not block the workspace in front of the cabinet. I was unable to observe the wiring inside the sub-panel at the time of the inspection.

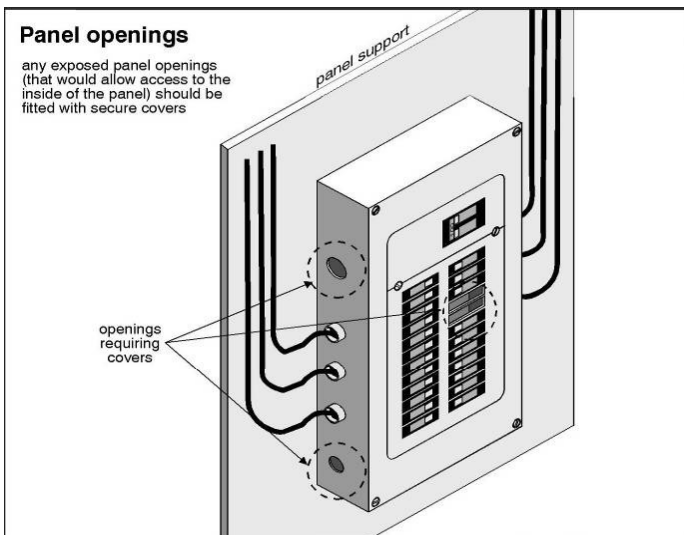
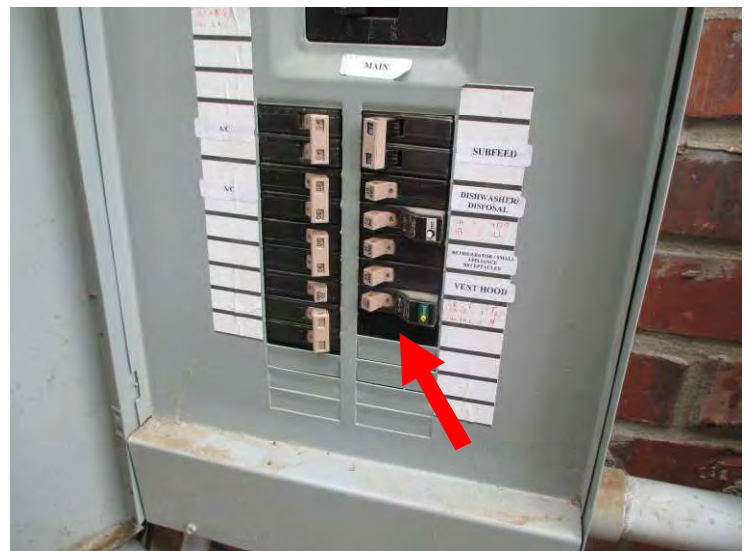
All breakers should be labeled.

Any openings in the main panel should be covered.

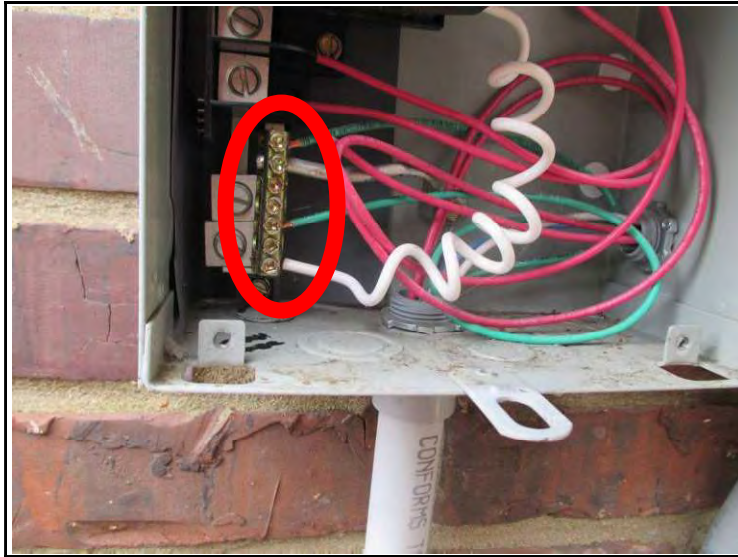
The ground wires and the neutral wires are not properly separated in the sub-panel electrical cabinet for the pool. The neutral wires should be on their own isolated bus bar and the ground wires should be connected to the sub-panel cabinet. Although the sub-panel is functional, it does not meet current National Electrical Code standards.

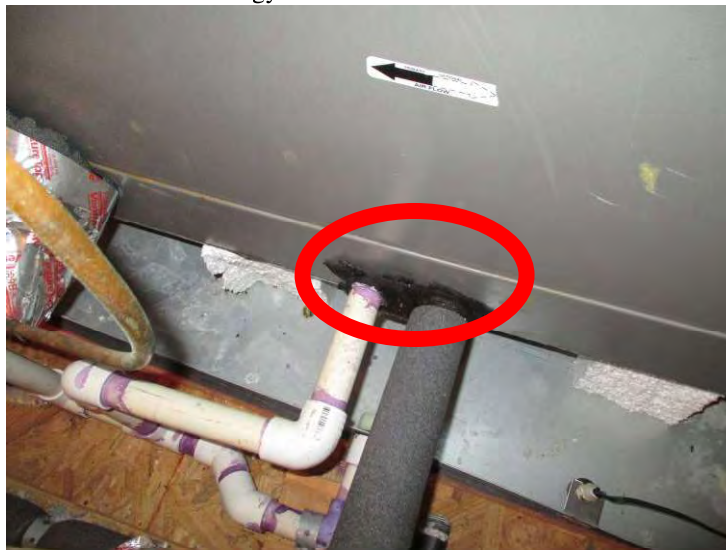
Minor air leaks at or around the evaporator coil were observed at the time of this inspection. Improvements will reduce air loss and energy costs.

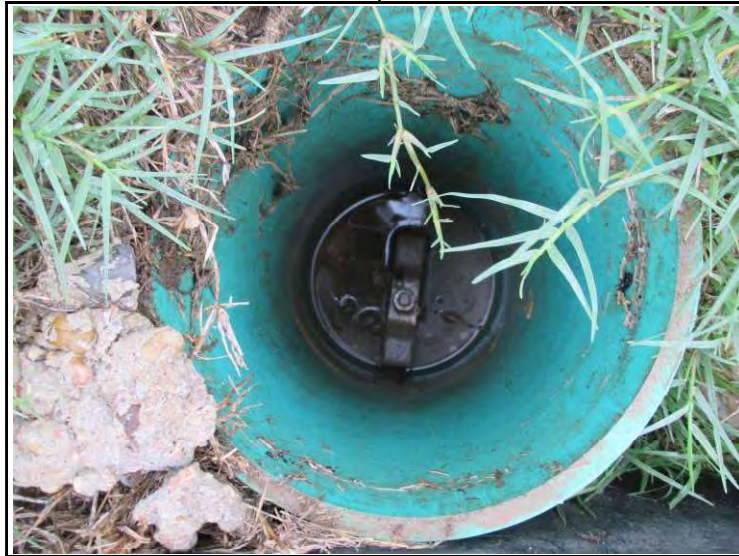
It should be verified that there is no leak at the water meter and customer shutoff. The boxes were observed to be full of water at the time of the inspection.

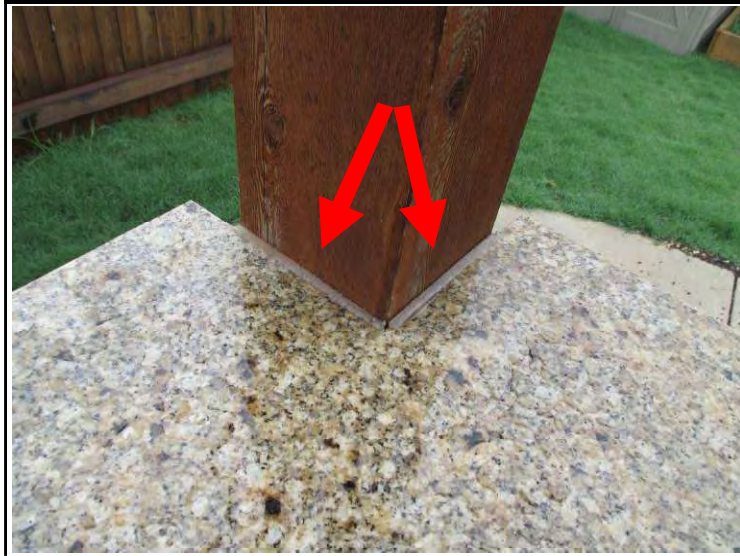
The counter at the outdoor kitchen should be sealed where the post meets the granite to prevent water infiltration.

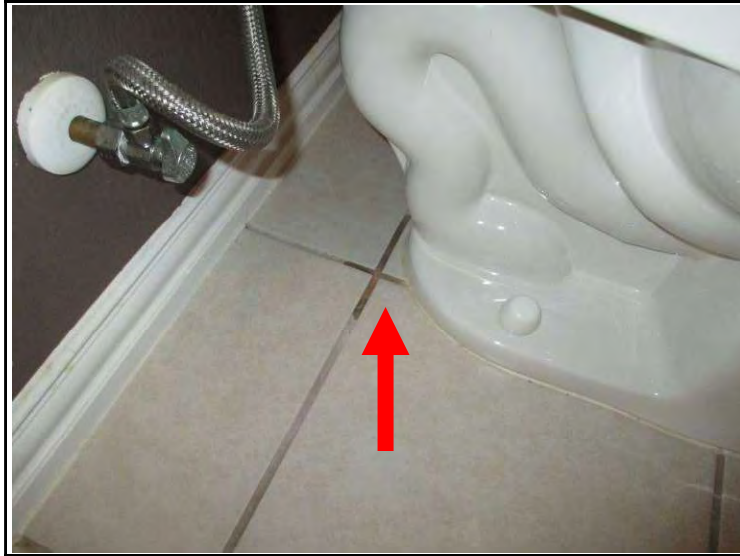
The floor adjacent to the toilet shows evidence of water staining. This condition should be evaluated and repaired as necessary repaired before further structural damage occurs.

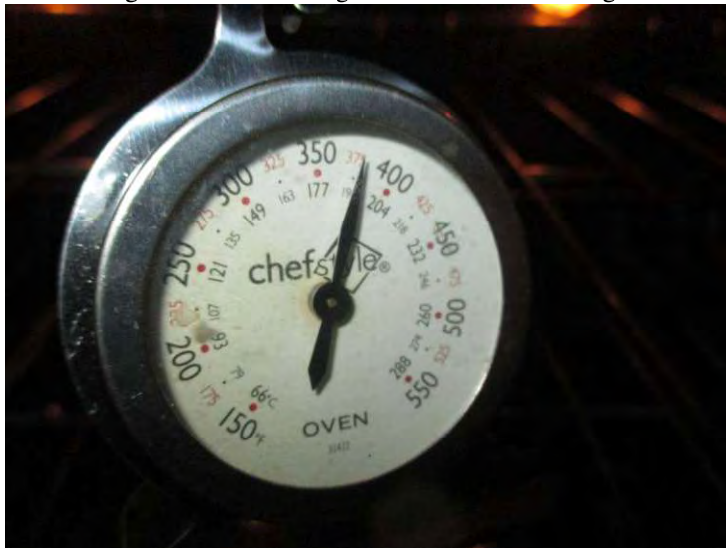
The thermostat for the electric range was found to be inaccurate and should be repaired. The temperature was found to be greater than a 25 degree difference of 350 degrees as measured by a detached thermometer.

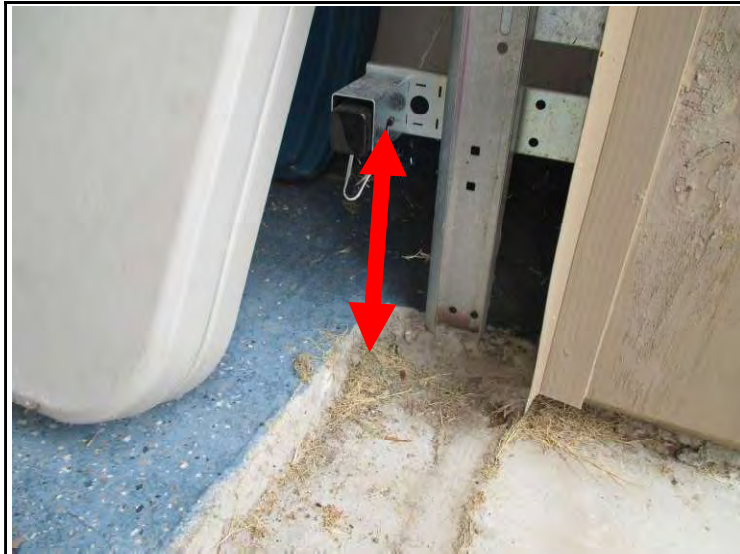
The electronic sensor for the garage door opener was found to be installed at an improper height. The sensors should be between 4 and 6 inches from the garage floor. This should be repaired as it poses a safety concern.

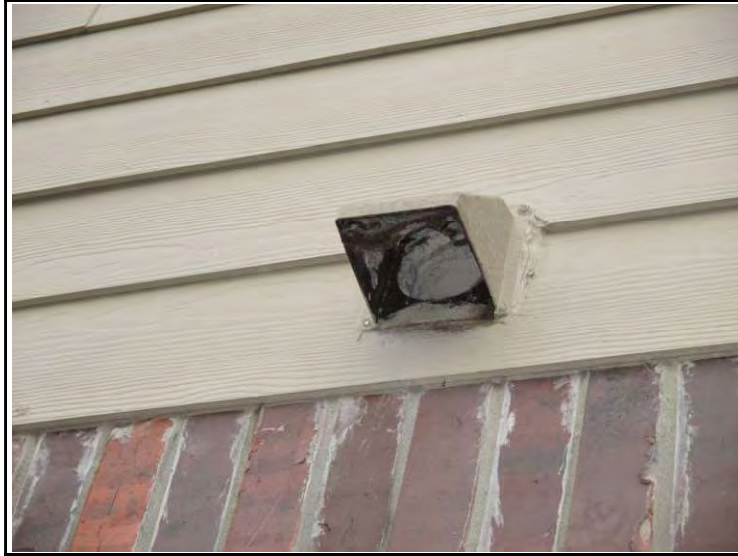
The back draft damper for the dryer is dirty and not closing properly.

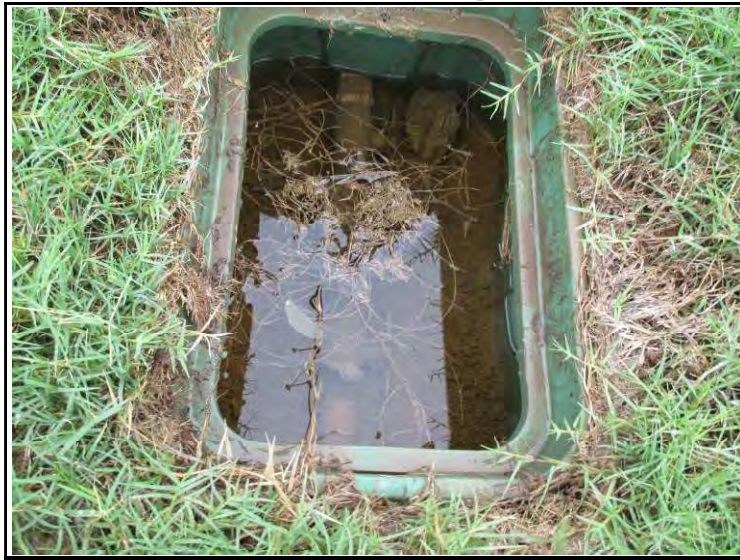
It should be verified that there is no leak at the anti-siphon valve for the sprinkler system. The box was observed to be full of water at the time of the inspection.

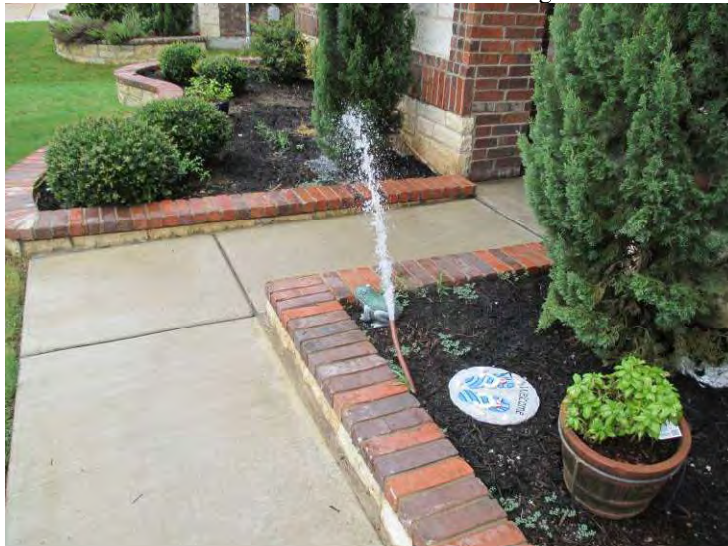
### Station 1

One or more of the soaker lines in this station are damaged and/or missing.

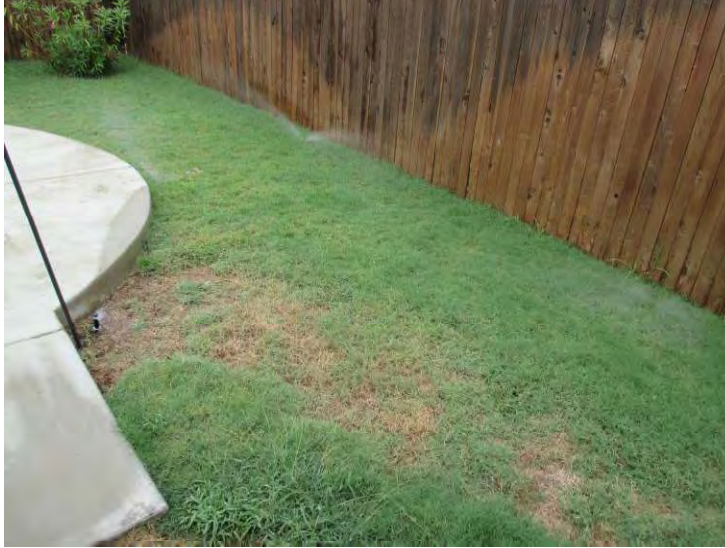
**Station 5**

One or more of the sprinkler heads in this station do not pop-up high enough to disperse water properly.

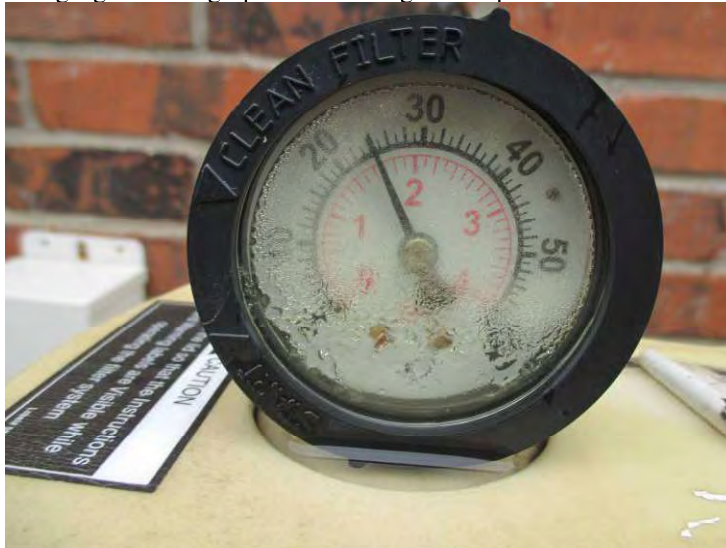
The filter gauge has a high pressure reading. Filter pressure should be maintained between 5 to 20 psi.

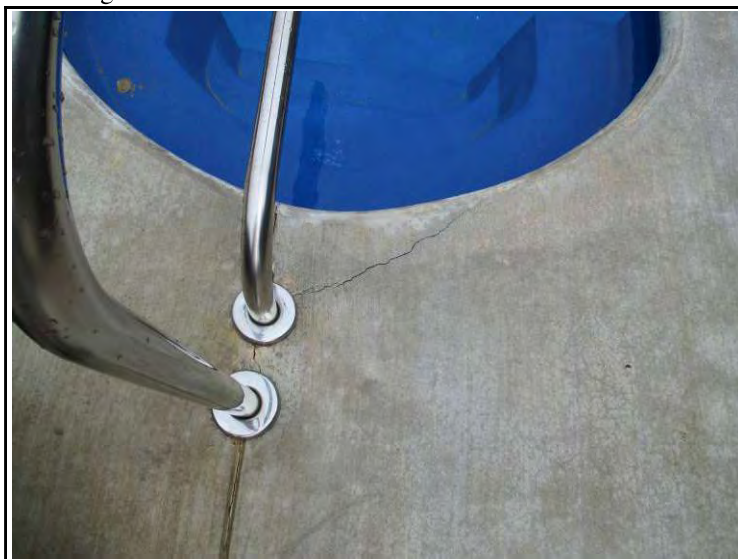
Some cracking of the deck was observed.
